# KANEPACKAGE PHILIPPINE INC.

## INVESTIGATION REPORT FORM (IRF)

Customer	ARKRAY	Attention To	WEENA APALLA
Item Code	84-05467A	Department	PRODUCTION
Item Description	INNER BOX F821629-1	Date of Detection	240708
Job Order Number	JO24-M-01076-4	Section Detected	QA SCREENING

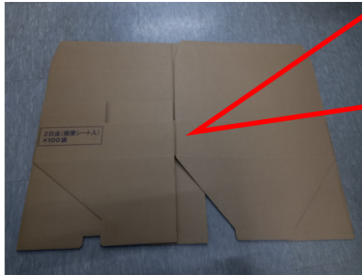
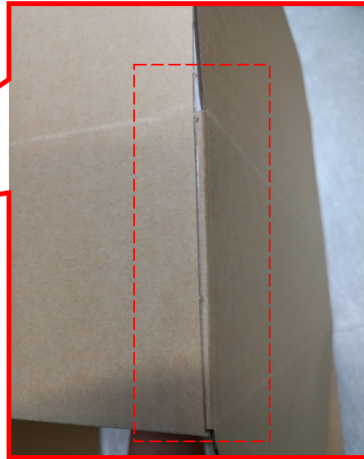
### ILLUSTRATION OF THE PROBLEM

MISALIGN GLUE

No misalign glue

With misalign glue

W1 Item already have existing improvement of putting nick mark in vertical and horizontal portion of glue tab as alignment reference during Gluing process. r n r nW2 The horizontal nick mark is effective since its visible but the vertical nick mark is not so visible possible because its along grain direction. r n r nw3 Based on investigation and interview to manual gluing operator there is difficulty to align the vertical gluing alignment of this item since the design is off set lower flap and the applied vertical nick mark in the glue tab is not visible.

Date Conducted: 2024-08-09	PIC: M. ASIS
Identified Rootcause Vertical nick mark is not visible in the glue tab	Recommendation N/A

WHY 1: Attachment of note in the die blade that inform the leader next running for the improvement of creasing matrix application on the glue tab.

WHY 2: Since the diecut process of this item is in Eterna the corrective action is the application of creasing matrix on the glue tab portion for more visible marking reference in gluing alignment.
