**KANEPACKAGE PHILIPPINE INC.**

INVESTIGATION REPORT FORM (IRF)

Control No.:		Date Issued	
0009		240711	
Customer	ARKRAY	Attention To	WEENA APALLA
Item Code	84-05467A	Department	PRODUCTION
Item Description	INNER BOX F821629-1	Date of Detection	240708
Job Order Number	JO24-M-01076-4	Section Detected	QA SCREENING

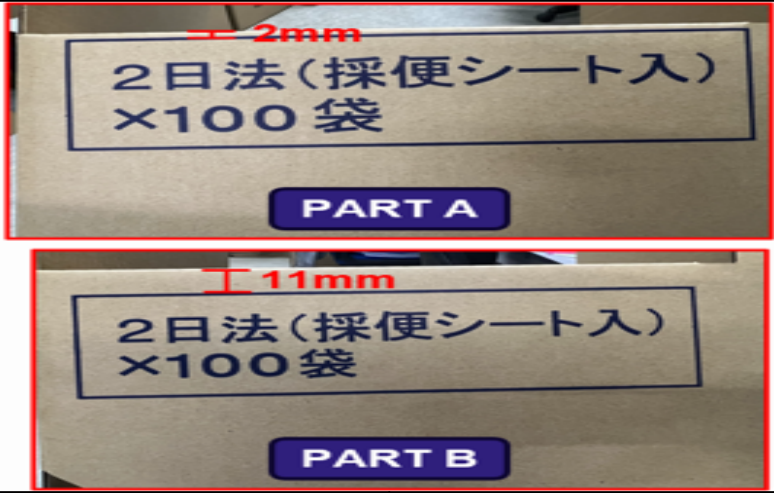
ILLUSTRATION OF THE PROBLEM

Lot Quantity (pcs)	Reject Qty (pcs)	Reject %
2050	27	1.32
Nature of Defect:		
MISALIGN DIECUT/CUT		
Requirement:		
Within print tolerance of ± 5		
Actual		
Above and below tolerance

WHY 1 : W1 We also consider misalign print in investigation but no factor found in Eqos since upon checking of CCTV Eqos operator follow on the Standard Height Limit Set in Eqos Feeder. r n r nW2 The factor that consider contributing random of misalign print is the abnormal lateral movement of Eterna die chase of almost 7mm due to worn out die chase spring. r n r nW3 The die chase movement corresponds on the misalignment based on the blade layout and print. r nSince only 8mm the gap of print to creasing line the movement of die chase resulted to random misalign diecut.

Date Conducted: 2024-07-31	PIC: M. ASIS
Identified Rootcause Worn-out die-chase spring	Recommendation Replacement of die-chase spring

WHY 1: Replacement of 6pcs worn out die chase spring.

WHY 2: Include the die chase spring in Engineering Machine History Sheet of Eterna. This is the basis of Engineering for the monitoring of machine parts life span for those parts that only Caledonian can maintenance or check.
