**KANE PACKAGE PHILIPPINE INC.**

INVESTIGATION REPORT FORM (IRF)

Customer	ARKRAY	Attention To	WEENA APALLA
Item Code	84-05467A	Department	PRODUCTION
Item Description	INNER BOX F821629-1	Date of Detection	240708
Job Order Number	JO24-M-01076-4	Section Detected	QA SCREENING

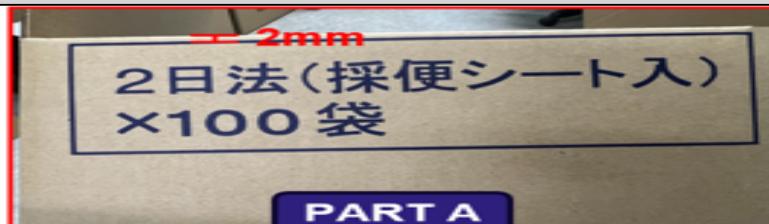
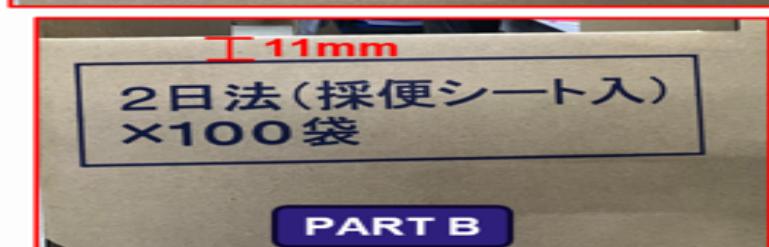
ILLUSTRATION OF THE PROBLEM

MISALIGN DIECUT/CUT

Within print tolerance of ± 5

Above and below tolerance

W1: We also consider misalign print in investigation but no factor found in Eqos since upon checking of CCTV Eqos operator follow on the Standard Height Limit Set in Eqos Feeder.
 W2: The factor that consider contributing random of misalign print is the abnormal lateral movement of Eterna die chase of almost 7mm due to worn out die chase spring.
 W3: The die chase movement corresponds on the misalignment based on the blade layout and print. Since only 8mm the gap of print to creasing line the movement of die chase resulted to random misalign diecut.

Date Conducted: 2024-07-31	PIC: M. ASIS
Identified Rootcause Worn-out die-chase spring	Recommendation Replacement of die-chase spring

WHY 1: Replacement of 6pcs worn out die chase spring.

Engineering Caledonian //
2024-07-31Include the die chase spring in Engineering Machine History Sheet of Eterna. This is the basis of
 WHY 2: Engineering for the monitoring of machine parts life span for those parts that only Caledonian can
 maintenance or check.
