**KANE PACKAGE PHILIPPINE INC.**

INVESTIGATION REPORT FORM (IRF)

Customer	INA MICRO OPTO CORP.	Attention To	WEENA APALLA
Item Code	AZ812400	Department	PRODUCTION
Item Description	CARTON	Date of Detection	241116
Job Order Number	JO-24-IPD-01058-4	Section Detected	QA SCREENING

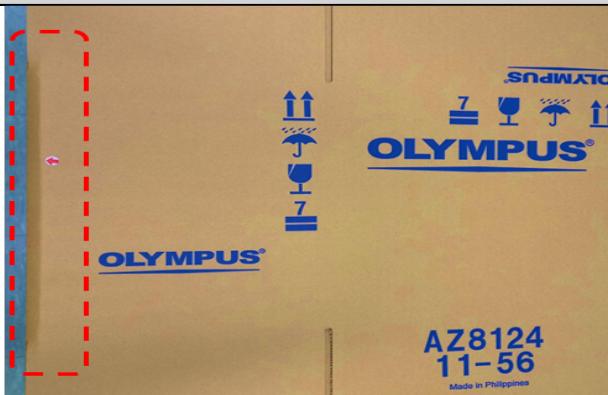
ACTUAL: With heavy extra fold up to 280 mm
REQUIREMENT: Extra fold is not acceptable

EXTRAFOLD

Heavy extra fold up to 280 mm

WHY 1 : W1 Operator conduct pre folding (hilot). r nW2 Operator is having difficulty folding along the creasing line. r nW3 Misalignment of creasing line happened that caused close and wide gap. r nW4 EQOS creasing roller hit the grain direction line of the board which is the hardest part.

Date Conducted: 2024-11-28	PIC: M.ASIS
Identified Rootcause EQOS creasing roller hit the grain direction line of the board.	Recommendation N/A

Remarks: The proposed of die-blade for this item for the improvement of creasing (the creasing impression already reached the maximum impression of 0.1mm) was declined since the item was slow moving and has small quantity.

The new corrective action from the production was re-orientation of pre-folding for this item. After the re-orientation, no extra fold issue was encountered.
