**KANE PACKAGE PHILIPPINE INC.**

INVESTIGATION REPORT FORM (IRF)

Control No.:	Date Issued
0040	241226

Customer	CANON BUSINESS MACHINE PHILS.	Attention To	REXEL ALMARIO
Item Code	3CB-0007-000/3CB-0008-000	Department	PRODUCTION
Item Description		Date of Detection	241216
Job Order Number	JO-F-24-1149-2, JO-F-24-1149-3	Section Detected	QA SCREENING

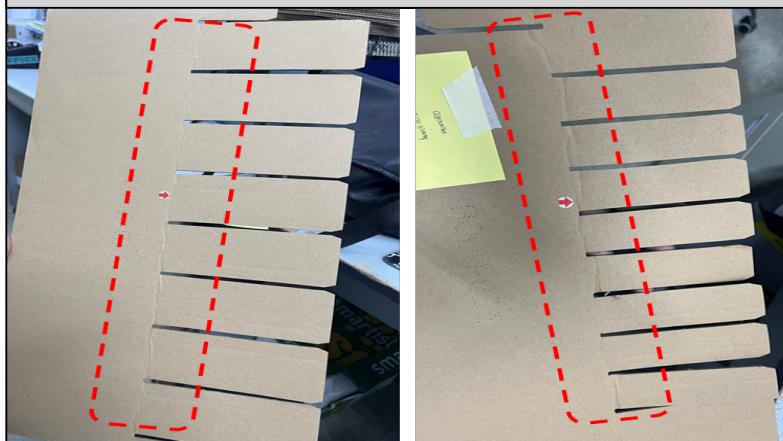
ILLUSTRATION OF THE PROBLEM

Nature of Defect:

SCORING

Requirement:

NO SCORING

Actual

WITH SCORING

WHY 1 : W1 PULLING FORCE WAS APPLIED ON ITEM DURING DETACHING PROCESS. r nW2 WORK INSTRUCTION FOR THE REMOVAL OF TRIMMINGS OF DIECUTTED BOARD WAS GENERAL TO ALL ITEMS (NEED EXTRA CAREFUL TO DETACH THIS ITEM SINCE THE SCORING ACCEPTABLE ON OTHER ITEMS IS REJECTED IN CBMP 3CB).

Date Conducted: 2025-05-02	PIC: M.ASIS
Identified Rootcause No proper detaching method for 3CB partitions	Recommendation Revision of detaching work instruction

WHY 1: CONDUCT AWARENESS ORIENTATION REGARDING THE ISSUE DURING PRODUCTION ASSEMBLY

WHY 2: GUIDELINES FOR PROPER DETACHING OF ITEMS
