**KANE PACKAGE PHILIPPINE INC.**

INVESTIGATION REPORT FORM (IRF)

Customer	MITSUMI PHILIPPINES INC.	Attention To	REXEL ALMARIO
Item Code	19-Y926 A	Department	PRODUCTION
Item Description	19-Y926 A DRT-J583 CARTON BOX-R	Date of Detection	250303
Job Order Number	JO25-M-00127-6	Section Detected	QA SCREENING

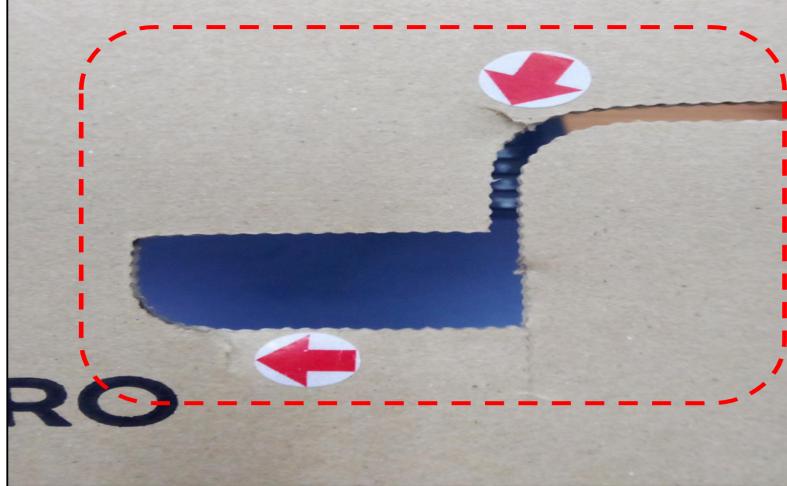
ILLUSTRATION OF THE PROBLEM

Lot Quantity (pcs)	Reject Qty (pcs)	Reject %
1600	67	4.19

TEAR OFF

WITH TEAR OFF

WHY 1 : Tear off occurred on the affected area during Detaching process

WHY 2 : There is an uncut portion during die cutting process.

WHY 3 : Cutting blade did not fully penetrate to the boards.

WHY 4 : Unbalance application of ejector sponge.

WHY 1: Back to zero layout

WHY 2: Alignment of WI PR 003 004 Guidelines in Using Diecut blade ejector layouting
