**KANEPACKAGE PHILIPPINE INC.**

INVESTIGATION REPORT FORM (IRF)

Customer	CANON BUSINESS MACHINE PHILS.	Attention To	REXEL ALMARIO
Item Code	RJ1-1228-00A	Department	PRODUCTION
Item Description	FIXING ASSY	Date of Detection	250301
Job Order Number	JO-F-25-240-10	Section Detected	QA SCREENING 3

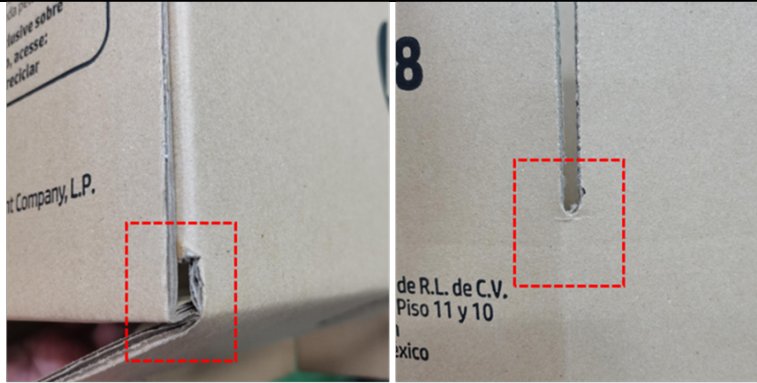
**ACTUAL:** With Poor slot and has gap of up to 6mm.**REQUIREMENT:** Acceptable up to 5mm.

POOR SLOT

WHY 1 : Movement of board during inline slitting at Eqos.

WHY 2 : Delayed timing in Eqos slitting process.

WHY 3 : Due to overstacking of materials at feeder gate.

WHY 1: Re orientation to operators regarding the set standard of stacking height limit per flute in EQOS feeder.

Date	2025-06-27	Time	08:00
Title	Reorientation on the stacking height Limit at the feeder of Eqos		
Attendees	Eqos Operators
