# KANEPACKAGE PHILIPPINE INC.

## INVESTIGATION REPORT FORM (IRF)

Customer	ARKRAY	Attention To	REXEL ALMARIO
Item Code	84-05467A	Department	PRODUCTION
Item Description	INNER BOX F821629-1	Date of Detection	250403
Job Order Number	JO25-M-00876-3	Section Detected	QA SCREENING

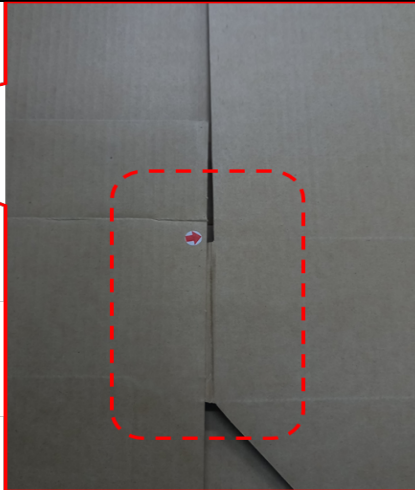
**ACTUAL:** Misalign glue of glue tab  
**REQUIREMENT:** Misalign glue is Acceptable up to 5mm

Lot Quantity (pcs)	Reject Qty (pcs)	Reject %
2100	30	1.43
Nature of Defect:		
MISALIGN GLUE		
Requirement:		
Misalign glue is Acceptable up to 5mm		
Actual		
Misalign glue of glue tab exceed set tolerance

WHY 1 : Operator got difficulty to trace the alignment during gluing process.

WHY 2 : The creasing line mark is not visible in the smooth surface can not adjust the r ndepth of creasing line to avoid bursting.

WHY 1: Request for tooling relay out regarding putting additional nick mark as guide in gluing alignment.
