**KANEPACKAGE PHILIPPINE INC.**

INVESTIGATION REPORT FORM (IRF)

Customer	CANON BUSINESS MACHINE PHILS.	Attention To	REXEL ALMARIO
Item Code	FJ8-0057-000-RMFG	Department	PRODUCTION
Item Description	FIXING ASSEMBLY, FX-102	Date of Detection	250822
Job Order Number	JO-TO-IPD-25-00216-1	Section Detected	QA SCREENING

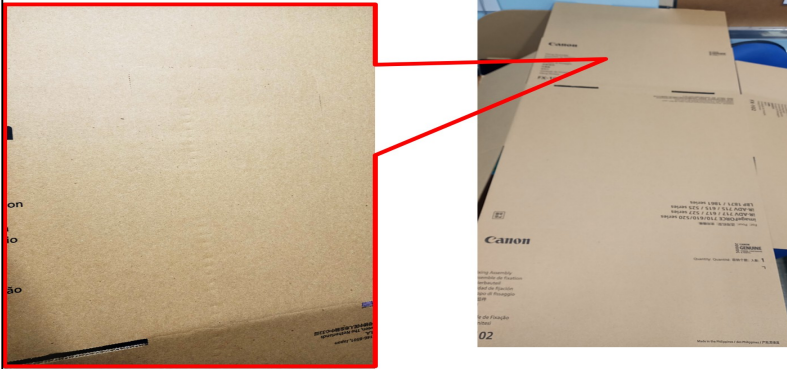
ACTUAL: With dent mark
REQUIREMENT: No dent mark

DENT

Dent mark should be only 25mm length by 25mm width

Dent mark up to 100 length

WHY 1 : W1 The volume of items loaded into the feeder is too heavy in EQOS that caused dent. r nW2 The operator fed the materials beyond the standard height limit of 300mm for EB flute. r nW3 The operator has difficulty checking the standard height limit marking from time to time during feeding.

WHY 1: PR for Line Laser Marker to help operators easily identify the standard feeding height limit.
