KANEPACKAGE PHILIPPINE INC.

INVESTIGATION REPORT FORM (IRF)

Customer	CANON BUSINESS MACHINE PHILS.	Attention To	REXEL ALMARIO
Item Code	FJ8-0057-000-RMFG	Department	PRODUCTION
Item Description	FIXING ASSEMBLY, FX-102	Date of Detection	250822
Job Order Number	JO-TO-IPD-25-00216-1	Section Detected	QA SCREENING

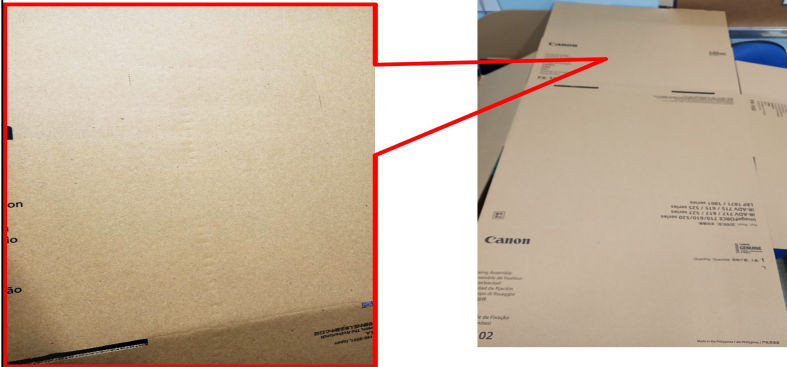
DENT

Dent mark should be only 25mm length by 25mm width

Dent mark up to 100 length

ACTUAL: With dent mark

REQUIREMENT: No dent mark

WHY 1 : W1 The volume of items loaded into the feeder is too heavy in EQOS that caused dent. r nW2 The operator fed the materials beyond the standard height limit of 300mm for EB flute. r nW3 The operator has difficulty checking the standard height limit marking from time to time during feeding.

WHY 1: PR for Line Laser Marker to help operators easily identify the standard feeding height limit.
