**KANEPACKAGE PHILIPPINE INC.**

INVESTIGATION REPORT FORM (IRF)

Customer	BROTHER INDUSTRIES PHILIPPINES, INC.	Attention To	REXEL ALMARIO
Item Code	D02RN1001	Department	PRODUCTION
Item Description	CARTON DEV UNIT ELLE (X3)	Date of Detection	251004
Job Order Number	JO25-M-03051-36	Section Detected	QA SCREENING 5

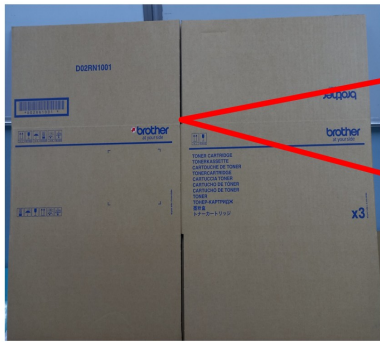
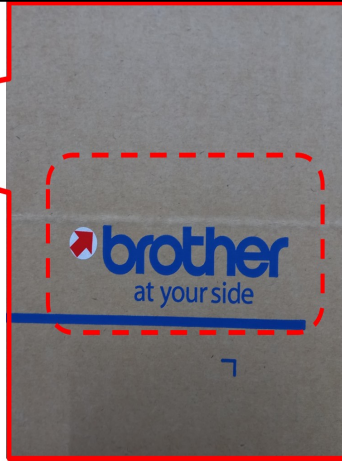
ILLUSTRATION OF THE PROBLEM

Actual: 3mm misalign print
Requirement: 17mm (tolerance:+5/-0)

Lot Quantity (pcs)	Reject Qty (pcs)	Reject %
1400	60	4.29
Nature of Defect:		
MISALIGN PRINT		
Requirement:		
17mm (tolerance:+5/-0)		
Actual		
3mm misalign print

WHY 1 : Misaligned diecut at Eterna.

WHY 2 : Random delayed feeding of materials.

WHY 3 : r n Stucked up bearing at feeder roller (findings during Eterna machine maintenance c/o Supplier) r nand worn out engineering plastic in the gripper bar causing misalign gripped.

WHY 1: Replacement of worn out machine part.
