**KANEPACKAGE PHILIPPINE INC.**

INVESTIGATION REPORT FORM (IRF)

Customer	BROTHER INDUSTRIES PHILIPPINES, INC.	Attention To	REXEL ALMARIO
Item Code	D028GY001	Department	PRODUCTION
Item Description	CARTON TN FCL X4	Date of Detection	251003
Job Order Number	JO25-M-03051-31	Section Detected	QA SCREENING 3

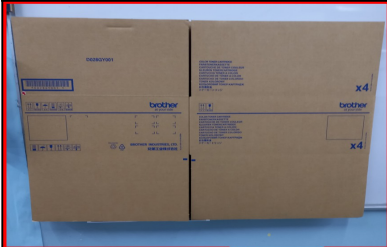
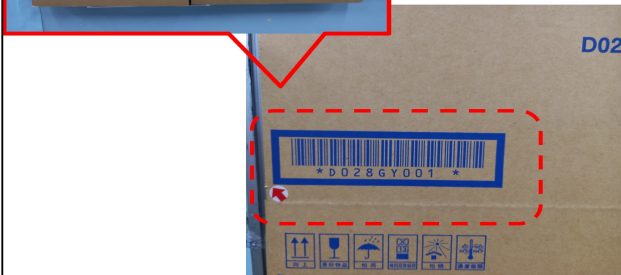
ILLUSTRATION OF THE PROBLEM

Actual: 4mm Print to creasing
Requirement: 11mm Print to creasing (Tolerance: +/-3mm)

Lot Quantity (pcs)	Reject Qty (pcs)	Reject %
1900	31	1.63
Nature of Defect:		
MISALIGN PRINT		
Requirement:		
11mm Print to creasing (Tolerance: +/-3mm)		
Actual		
4mm Print to creasing

WHY 1 : Misaligned diecut at Eterna.

WHY 2 : Random delayed feeding of materials.

WHY 3 : Stucked up bearing at feeder roller (findings during Eterna machine maintenance c/o Supplier) r nand worn out engineering plastic in the gripper bar causing misalign gripped.

WHY 1: Replacement of worn out machine part..
