**KANE PACKAGE PHILIPPINE INC.**

INVESTIGATION REPORT FORM (IRF)

Customer	SANYO DENKI PHILS INC.	Attention To	REXEL ALMARIO
Item Code	00902010-01	Department	PRODUCTION
Item Description	PRINT SPECIFICATION	Date of Detection	251024
Job Order Number	JO25-M-03229-74	Section Detected	QA SCREENING 2

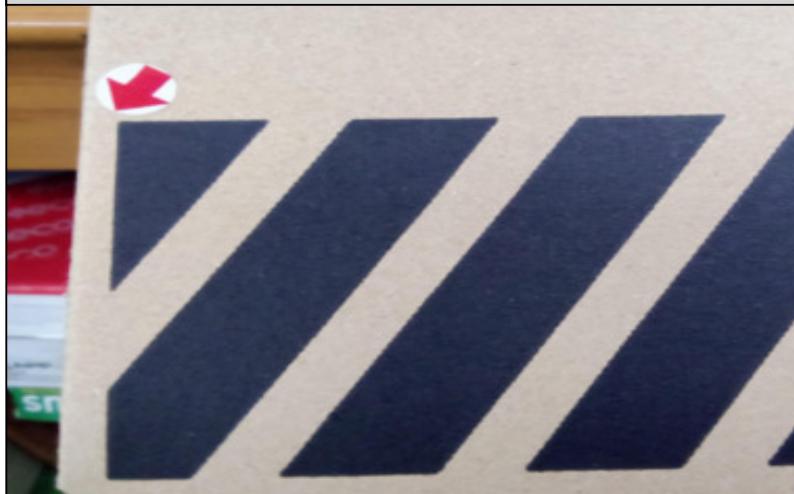
ILLUSTRATION OF THE PROBLEM

MISALIGN PRINT

Solid black print within the folding line (Printing tolerance: +-3mm)

Misalign up to 5mm

WHY 1 : W1 The volume of items loaded into the feeder is too heavy. r nW2 The operator fed the materials beyond the standard height limit of 300mm for EB flute. r nW3 The operator has difficulty checking the standard height limit marking from time to time during feeding.

WHY 1: PR for Line Laser Marker to help operators easily identify the standard feeding height limit.
