**KANEPACKAGE PHILIPPINE INC.**

INVESTIGATION REPORT FORM (IRF)

Customer: EPSON PRECISION PHILIPPINES INCORPORATED - IJP

Item Code: 516713800 PANEL A

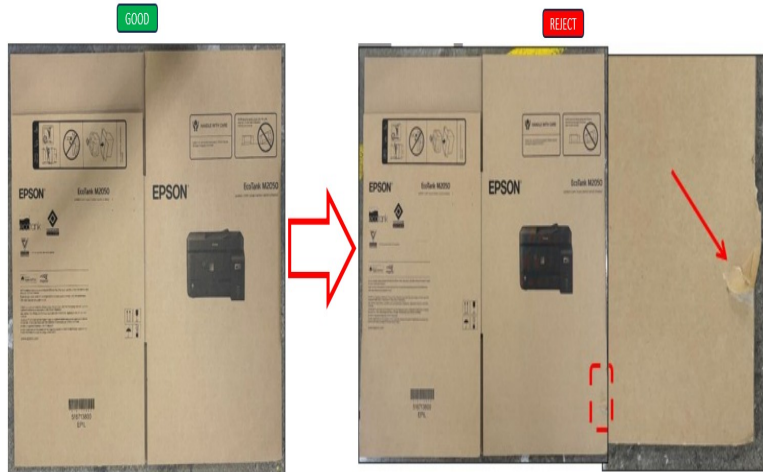
ILLUSTRATION OF THE PROBLEM

PEEL OFF

PEEL OCCUR ON UPPER AND LOWER FLAP SIDE PORTION DUE TO UNCUT

WHY 1 : Misalign cut was due to the deformation of PS item

WHY 2 : The deformation of PS was due to applied covered stretch film thin PS prone to deformation during stocking process in the loading area that hit the feeder sensor

WHY 3 : A thin printed sheet hit the cover of upper feeder sensor during mass production

WHY 4 : when printed sheet hits the feeder sensor it will cause to failed to detect the passing of the printed sheet that cause misalign between printed sheet to single face

WHY 1: Operator to pressed the 4 corner of the printed sheet to avoid touching the feeder sensor cover
