**KANEPACKAGE PHILIPPINE INC.**

INVESTIGATION REPORT FORM (IRF)

Customer: EPSON PRECISION PHILIPPINES INCORPORATED - IJP

Item Code: 5167003-00

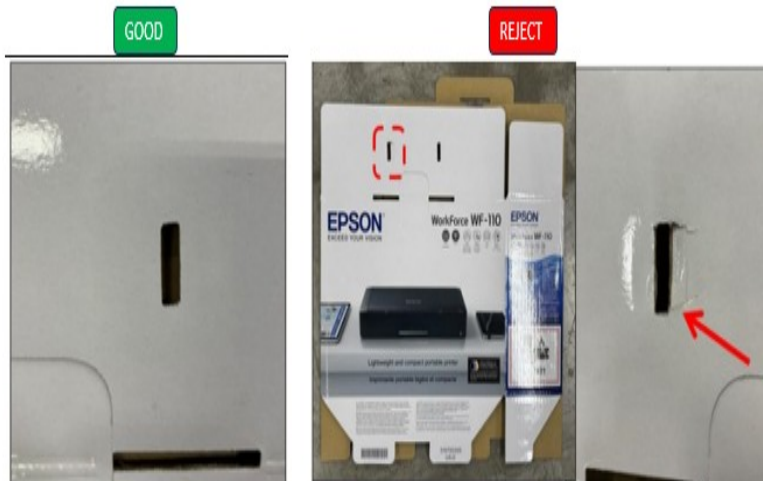
ILLUSTRATION OF THE PROBLEM

DAMAGED

DAMAGED ON ACTUAL/ APPEARANCE OCCUR DURING MANUAL DETACHING

WHY 1 : The slot portion of the ICB is damaged during the detaching of the scrap

WHY 2 : The detaching tool used hits and damages the slot portion

WHY 3 : The detaching tool being used is not appropriate for the slot of the ICB

WHY 4 : An improvised tool(specifically a cyrel stick) is being used instead of the correct purpose designed tool

WHY 1: request and fabricate tool for detaching process

Date	2025-10-06	Time	09:30
Title	orientation of proper detaching of item using the correct toll that has been provided		
Attendees	detaching operator
