**INVESTIGATION REPORT FORM (IRF)**

Customer: EPSON PRECISION PHILIPPINES INCORPORATED - IJP

Item Description: MUFFIN CARTON BOX ,CK81010

Job Order Number: JOL-0016992

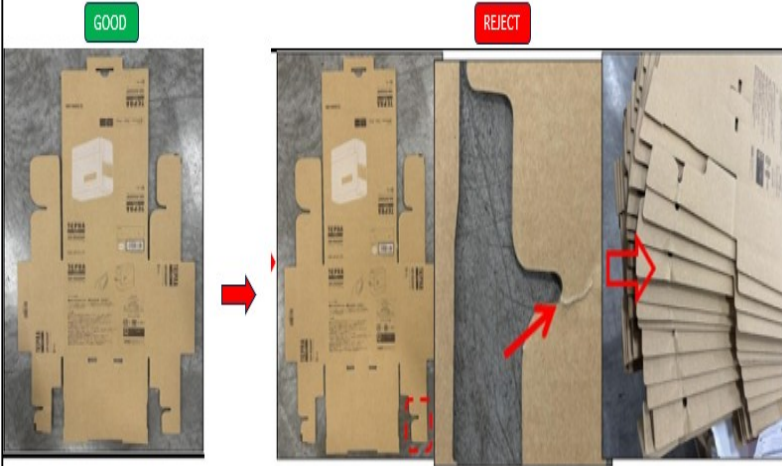
**ILLUSTRATION OF THE PROBLEM**

DAMAGED

THE ACTUAL DAMAGED OCCURED DURING MANUAL DETACHING

WHY 1 : Damaged occur during the manual stripping process

WHY 2 : during the pulling of the scrap material the affected portion also pulled out causing to damaged

WHY 3 : The affected portion has no cutting blade

WHY 4 : The stripping process of the scrap is not considered during the design of the die cut blade

WHY 1: Attached a sutera blade to cut on the affected portion and separate it during pulling of the outer scrap
