**KANEPACKAGE PHILIPPINE INC.**

INVESTIGATION REPORT FORM (IRF)☒ Inhouse Detection☐ Customer Claim

Customer	EPSON IJP	Attention To	Mr. Gerald De Guzman / Ms. Weena Apalla
Item Code	5147239-00	Department	PRODUCTION
Item Description	OUTER CARTON BOX	Date of Detection	20 01 16
Job Order Number	WO-20-M-00006-17	Section Detected	QA - SCREENING

INVESTIGATION REPORT FOR MISALIGN SLOT OF EPSON IJP 514723900 OUTER CARTON BOX

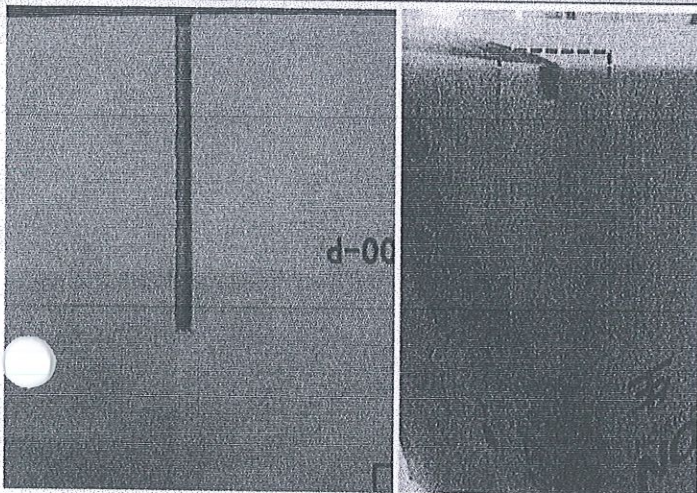
ILLUSTRATION OF THE PROBLEM

MISALIGN SLOT

The slot of the item should be within the creasing line and within the tolerance of $\pm 5\text{mm}$

The slot exceeded on the creasing line

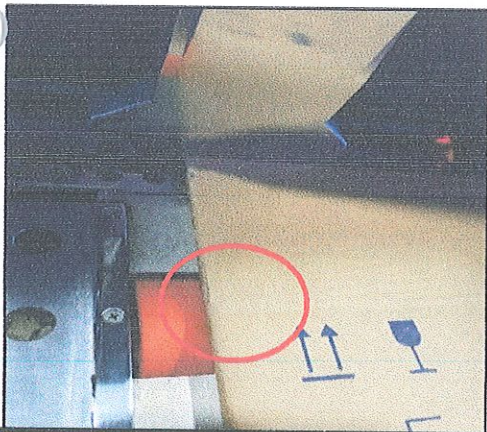
W2 - The creasing line exactly hit the center of orange rubber roller who grip or push the materials inside the machine.

The orange rubber roller can't grip or push well the materials because of creasing line specially at the end portion of process

adjust the 2 pull nip of the machine to tight
the gripping
1 Pull nip: from 5.3mm to 4.8mm
2 Pull nip: from 5.3mm to 5.4mm
Feed Gate: from 9.0mm to 8.9mm } Feeding Unit

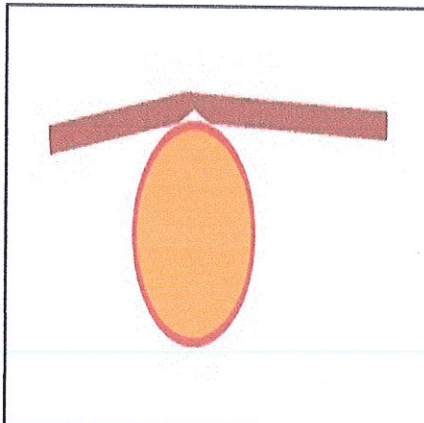
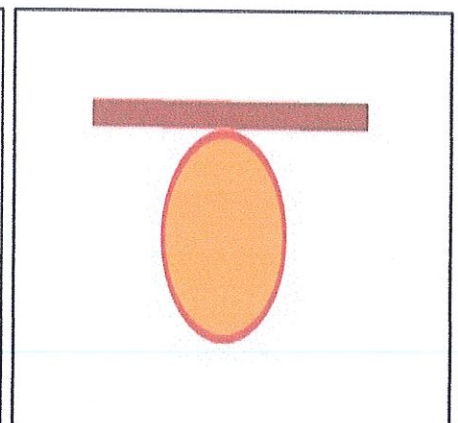
Good condition

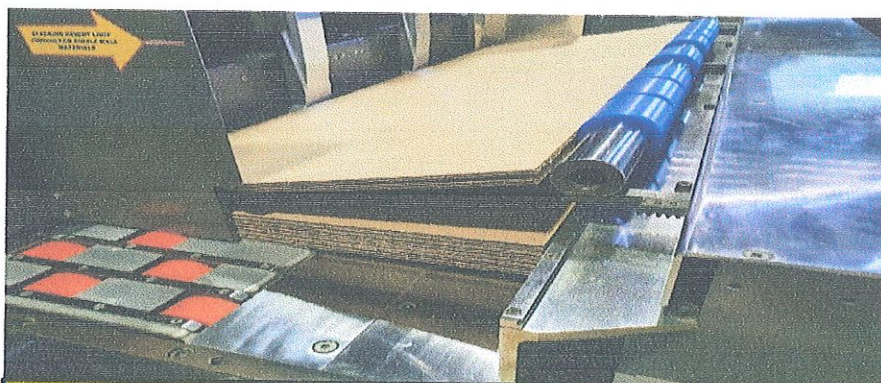
W3 - Possible the occurrence happened in the end portion of process because weight in the bottom material become light.

End portion of process the weight in the bottom materials become light
