**KANEPACKAGE PHILIPPINE INC.**

**INVESTIGATION REPORT FORM (IRF)**☒ Inhouse Detection☐ Customer Claim

Control No.: 157

| Item Description | Z10 BOX OUTER | Date of Detection | 20 01 24 |

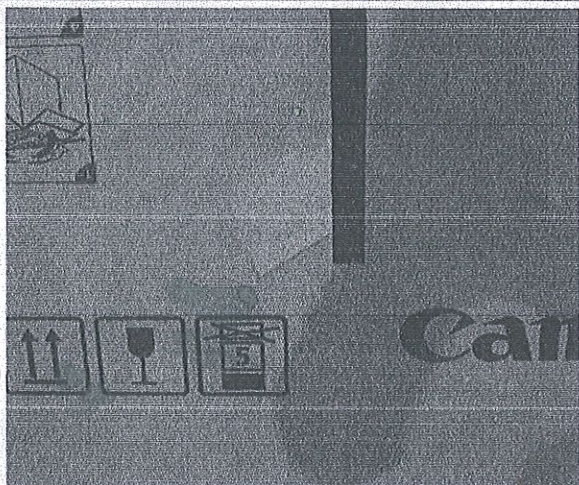
PEEL-OFF

For Class B &amp; C: 100mm x 5mm Peel-off is acceptable

50mm x 60mm Peel-off on the flap

| Process / Material | Why 1: | INSUFFICIENT CUTTING OF DIE-BLADE DURING DIECUT PROCESS. | Why 1: | NO OCCURENCE OF PEEL-OFF DURING TRIAL RUN |
| | Why 2: | EVEN THE CUTTING WAS GOOD ON THE START OF MASS | Why 2: | IN DIECUT S1700. |
| | Why 3: | PRODUCTION, THERE ARE TIME THAT THE BACKING TAPE | Why 3: | PEEL OF HARD TO DETECT EARLY BECAUSE ITEM |
| | Why 4: | WAS BREAK DUE TO HARDNESS OF MATERIALS WHY | Why 4: | WAS FACING ROUGH SURFACE ON TOP DURING |
| | Why 5: | SOME PORTION GOT UNCUT. | Why 5: | PROCESS. |

THE UNCUT BECAME PEEL OFF DUE TO STRIPPING PROCESS.

OPERATOR MISSED THE SAMPLING FOR THE LAST BATCH (25 PCS) OF MATERIALS.

~ The kraftliner @ the smooth surface was pulled along w/ trimming during stripping since there was uncut liner on the slot of the item that still connected w/ trimming, because the impact of the diecut blade is not enough to pierce completely the material

| Process | - REPLACEMENT OF BROKEN BACKING TAPE<br>- BOXES WITH AUTO STRIP WILL PALLETIZE SMOOTH SURFACE ON TOP FOR VISUAL CHECKING OF PEEL OFF<br>- RE-ORIENTATION REGARDING SAMPLING CHECKING PER BATCH (25 PCS). | PRODUCTION UPON DETECTION<br>PRODUCTION DONE<br>200130 |

~ Upgrade backing tape used from clear tape to steel tape (AS cutting impression support)  
~ Increase the pressure from on the range of 80 - 90 Psi.
