**KANEPACKAGE PHILIPPINE INC.**

**INVESTIGATION REPORT FORM (IRF)**☒ Inhouse Detection☐ Customer Claim

# INVESTIGATION REPORT FOR MISALIGN GLUING OF EMORI HP01D2200 CARTON BOX

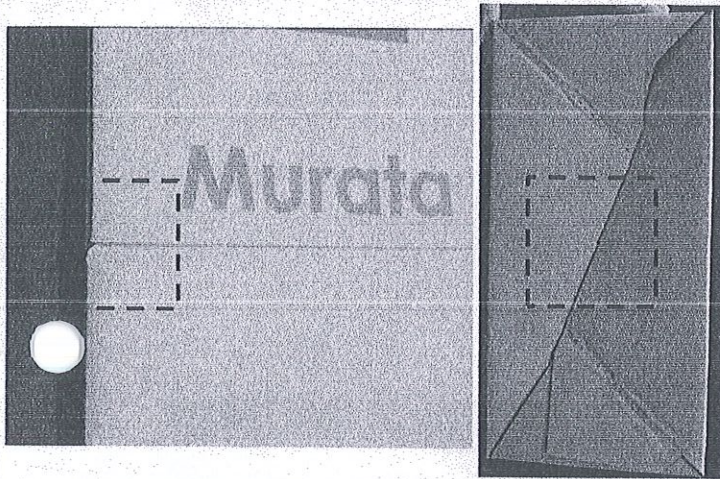
MISALIGN GLUING

The bottom part of the box should be even

The bottom part of the box is not even the it is not locking

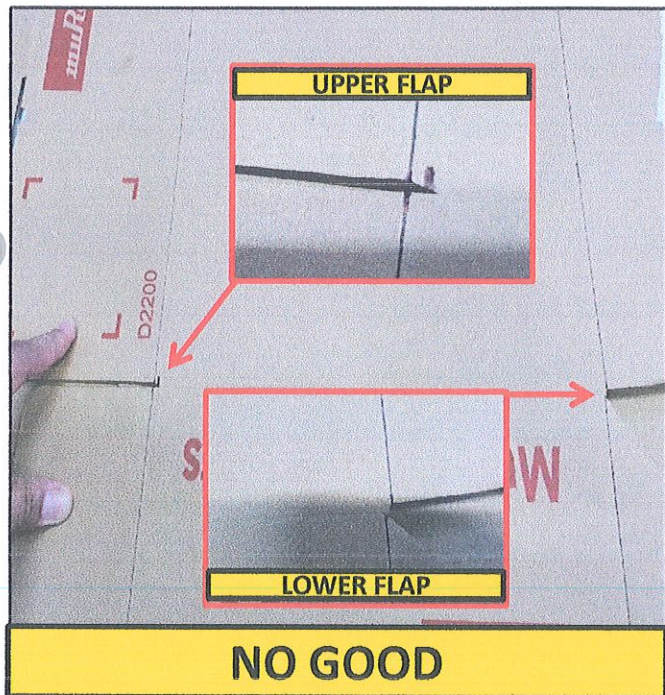
**DIRECT CAUSE** W1 - The required alignment of creasing line in the upper flap is uneven.

**PROCESS / MATERIAL** W2 - Operator align straight the creasing in the upper flap, because it was facing to operator during feeding of item in Gluing Conveyor.

> Put Nick mark as Pokayoke mark for the alignment of gluing.

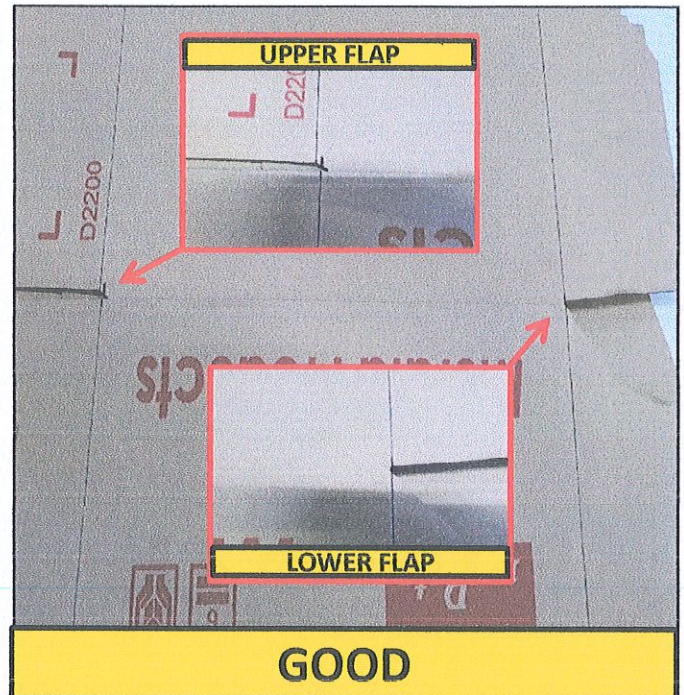
**DIRECT CAUSED** W1 - Possible that the other Operator is not familiar or aware regarding the Gluing alignment requirement for this item.

**PROCESS / MATERIAL** W2 - The man power rotation in Manual Gluing for using Conveyor start last December 2019.

> Orientation regarding the gluing alignment requirement for Emori D2200 Carton Box.
