**KANEPACKAGE PHILIPPINE INC.**

INVESTIGATION REPORT FORM (IRF)☐ Inhouse Detection☒ Customer Claim

Control No.: 171

Customer	SANYO DENKI
Item Code	00902009-01
Item Description	PRINT SPECIFICATION
Job Order Number	WO-DRS-20-M-00087-122

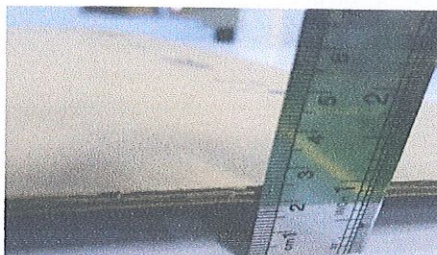
- W1** - Cannot identify between Egos and Eterna the caused of Misalign Print/Diecut, but 1 of the Factor and have a proof that cause of misalign is the warp materials.
- W2** - Egos operator conducted Study that the Random warp materials have big effect to Print movement.
- W3** - Eterna record the machine ERROR downtime due to warp material. This machine error is one of the big factor of misalign diecut.

RANDOM WARP MATERIALS with 18mm WARPAGE

- > From 6outs with materials of 1025 X 1584 BF that (Prone to warp because Big sheets). The 3pm team propose to back in 1out with materials of 484 X 933 BF (Not prone to warp).

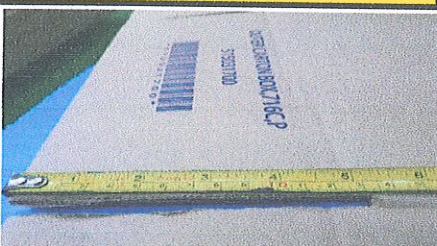
**Print move 8mm upward for warp materials
(Requirement 25mm vs. Actual 17mm)**

The lower flap slot move 12mm
upward
(Requirement 119mm vs. Actual
131 mm)

~ Change rubber die & diecut blade layout from 6outs to 1 out
~ Put pokayoke mark on the mylar of the item to monitor the timing of material entry in printing unit
~ Apply same CA to 00902009-01
