**KANEPACKAGE PHILIPPINE INC.**

INVESTIGATION REPORT FORM (IRF)☐ Inhouse Detection☒ Customer Claim

Customer	EPSON IJP
Item Code	5150864-01
Item Description	R41416914 (SILANE) INDIVIDUAL BOX; PA1
Job Order Number	PLEASE SEE ATTACHED

INVESTIGATION REPORT FOR EXCESS GLUE / GLUE STAIN OF EPSON IJP 5150864-01

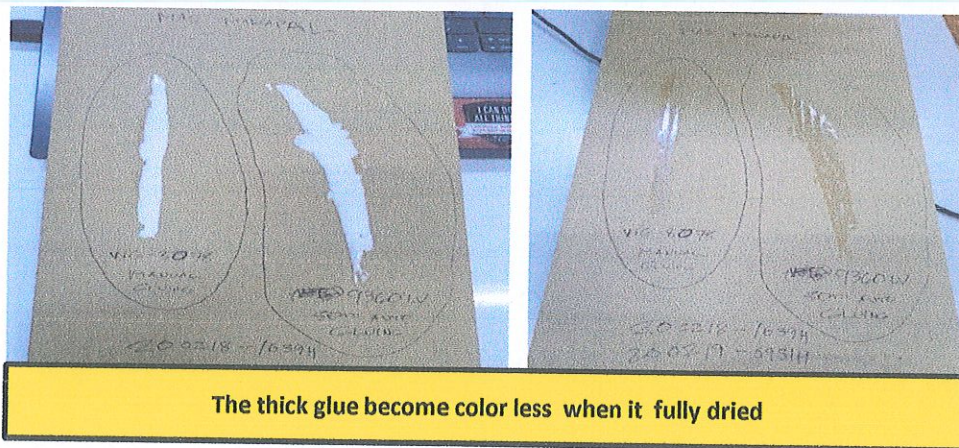
DIRECT CAUSE PROCESS/MATERIAL	W1 - The excess glue is inherent in Semi Auto Gluing.
	W2 - Due to manual feeding of item if operator got delay or stop for a few second, the distribution of glue in the glue tab become thicker that caused excess glue.

INDIRECT CAUSE PROCESS/MATERIAL	W1 - Operator did not notice the excess glue.
	W2 - No excess glue detected upon sampling checking.
	W3 - Our thinking when the glue got dry it become color less, why is not critical specially in the glue tab side because its inherent.

> Orient the Semi Auto Gluing operator to wipe out if there is thick excess glue in the glue tab.
