KANEPACKAGE PHILIPPINE INC.

INVESTIGATION REPORT FORM (IRF)
☒ Inhouse Detection

Customer	CANON	Attention To	Mr. Gerald De Guzman / Ms. Weena Apalla
Item Code	RX1-5115-000	Department	PRODUCTION
Item Description	Z10_ACC_BOX	Date of Detection	20 02 25
Job Order Number	WO-F-20-032-1	Section Detected	QA - SCREENING

INVESTIGATION REPORT FOR BURSTING OF CBMP RX1-5115-000 Z10_ACC_BOX

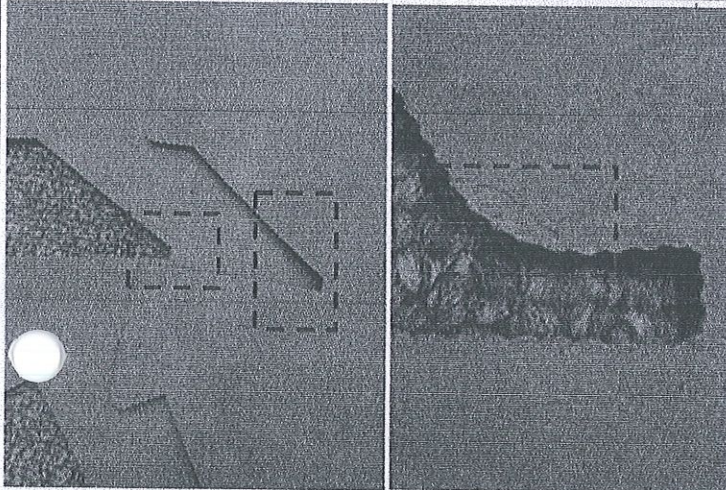
Peel-off

Peel-off occurs on the flaps and visible during assembly

- UUCUT PORTION BECOME PEEL-OFF
DUE TO AUTO STRIPPING

~ The Kraftliner was pulled down w/ the trimmings,
because there was undetached / not completely cut liner
since the pressure applied on the affected part is
not enough to pierce the liner

DIRECT CAUSE PROCESS/MATERIAL	W1 - Uncut portion is inherent in diecut operation, because the blade become blunt or even the Eterna plate have deep marking of blade shots due to multiple usage of diecut blade.
	W2 - The uncut portion become Peel-Off due to auto stripping process of this item in Eterna.

~ Additional Backing tape on the pattern of
the diecut blade of the item
~ Weld fully the connectors of the diecut blade

> Put backing tape in diecut blade to Peel-off or uncut portion.
