**KANEPACKAGE PHILIPPINE INC.**

INVESTIGATION REPORT FORM (IRF)☒ Inhouse Detection☐ Customer Claim

Customer	NIDEC SUBIC
Item Code	VR-C RYZXD000002
Item Description	PAD A
Job Order Number	WO-IPD-850-3

INVESTIGATION REPORT FOR BURSTING OF NIDEC SUBIC VR- C RYZXD000002 PAD A (IPD)

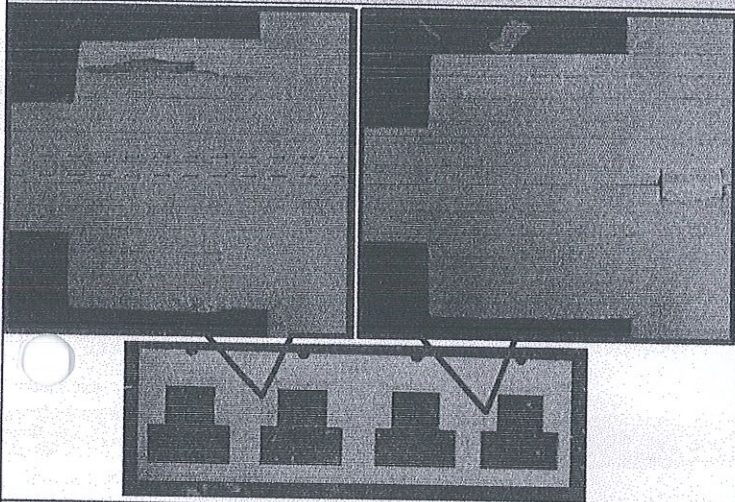
BURSTING

No bursting on the surface of the item

Bursting occurred on any part of the item

- NO SPACING LAYOUT OF RUBBER SPONGE
IN THE DIE CUT BLADE THAT POSSIBLE CAUSED
OF BURSTING.

-Tight impression of die cut blade on the corrugated material

1. Additional cushion on the diecut blade to reduce the impact to the material
2. Relayout the diecut blade from gray ejector to eperan cushion

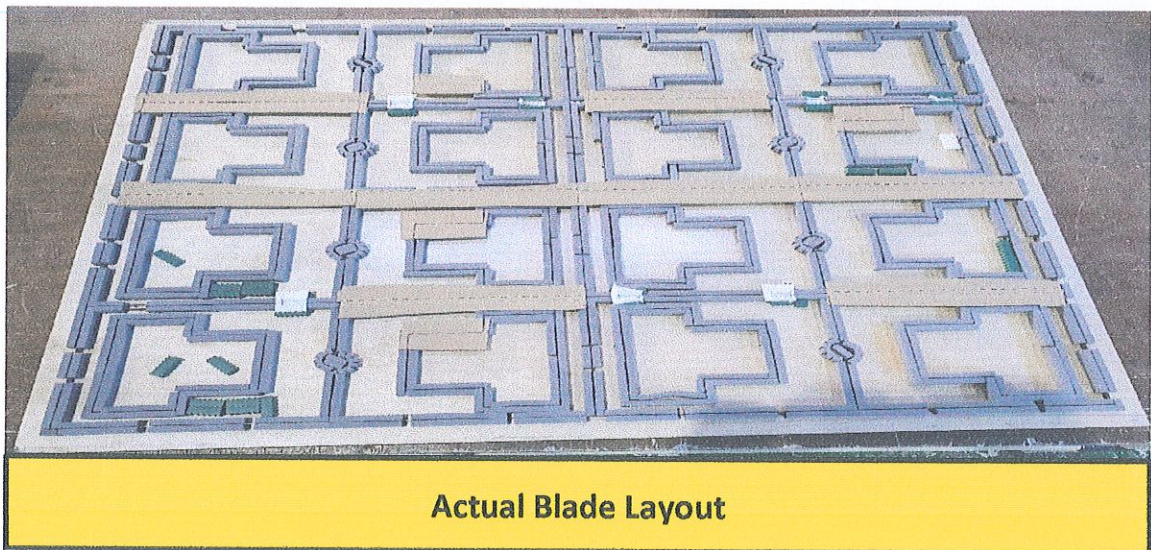
DIRECT CAUSE PROCESS/MATERIAL	W1 - Possible caused of the occurrence is because the air pressure during impression in penetrate in the item.
	W2 - No spacing layout of rubber sponge in the diecut blade.

INDIRECT CAUSE PROCESS/MATERIAL	W1 - Trial run approved by ME why they proceed in mass production.
	W2- Operator did not notice the affected of bursting during sampling.
	W3- Possible not all 6 outs are affected and the released of the items in receiver is per batch of 25pcs.

> Re-layout of diecut blade and put spacing in the rubber sponge.
