**KANEPACKAGE PHILIPPINE INC.**

**INVESTIGATION REPORT FORM (IRF)**☒ Inhouse Detection☐ Customer Claim

# INVESTIGATION REPORT FOR EXCESS PRINT OF TERADYNE PR02302G BOX

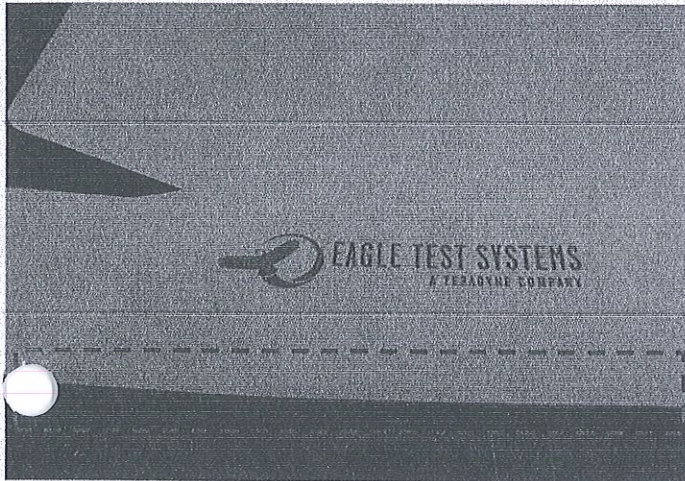
MISALIGN PRINT (EXCESS PRINT)

Suteban marking should not appear on the item

Small portion of the suteban appear on the flap of the item

- POSSIBLE THE PRINT GOT MOVE  
BECAUSE OF RANDOM WARP MATERIALS.

The cutuban of the rubber die is near on the  
flap part of the item, the movement of the  
printing is 3mm only

~same w/ the propose CA.:  
Move the cutuban gripper by 6mm

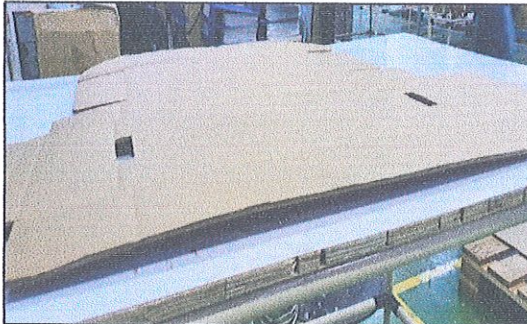
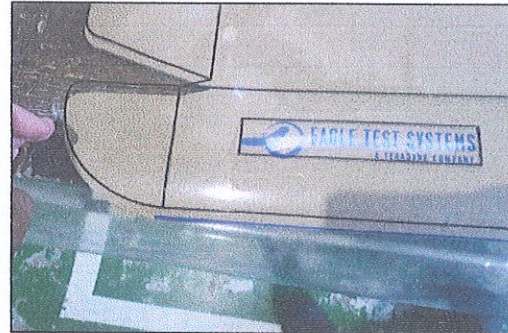
<b>DIRECT CAUSE PROCESS/MATERIAL</b>	<b>W1-</b> The possible factor of problem is the print movement in Eqos.
	<b>W2-</b> We notice that the reject items is warp that possible caused of print movement.
