**KANEPACKAGE PHILIPPINE INC.**

**INVESTIGATION REPORT FORM (IRF)**☒ Inhouse Detection☐ Customer Claim

Customer	MERASENKO	Attention To	Mr. Gerald De Guzman / Ms. Weena Apalla
Item Code	N / A	Department	PRODUCTION
Item Description	A1 BOX	Date of Detection	20 06 12
Job Order Number	WO-20-C-0119-4	Section Detected	QA - OQA

# INVESTIGATION REPORT FOR WRONG GRAIN DIRECTION OF MERASENKO A1 BOX

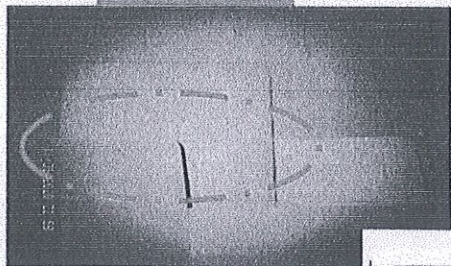
**ILLUSTRATION OF THE PROBLEM**☒ Major☐ Minor**NO GOOD**

Nature of Defect:

WRONG GRAIN DIRECTION

Grain Direction should be horizontal

Grain Direction is vertical

WRONG PILE ORIENTATION OF MATERIALS  
IN DIECUT S1700 FEEDER

~ Put note on the back of the diecut blade that  
the item grain direction is horizontal
