**KANEPACKAGE PHILIPPINE INC.**

INVESTIGATION REPORT FORM (IRF)☒ Inhouse Detection☐ Customer Claim

Control No.: 228

INVESTIGATION REPORT FOR WRONG ASSEMBLY OF CBMP RJ1-0926 REAR DOOR ASSY

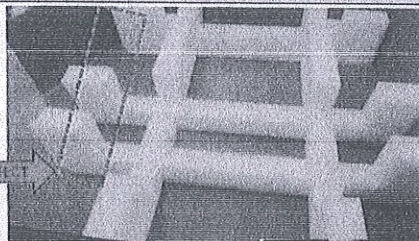
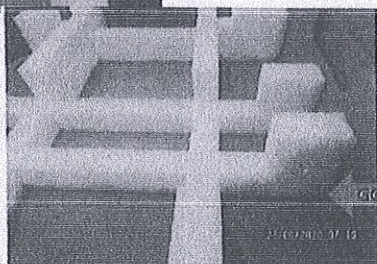
WRONG ASSEMBLY

Chamfer should be located on the right part

Chamfer is located on the left side

- BASED ON STANDARD OPERATOR RELY THE ASSEMBLY ON APPROVED SAMPLE BUT SUDDENLY THE SAMPLE IS WRONG ASSY.

- THE POSITION OF CHAMFER IN THE DRAWING IS NOT CLEAR.

~ Wrong assembly of cushion because the chamfer was located on the backpart of the assembly. The chamfer was not visible on the assembly drawing

~ change the view of the assembly drawing where the chamfer is visible

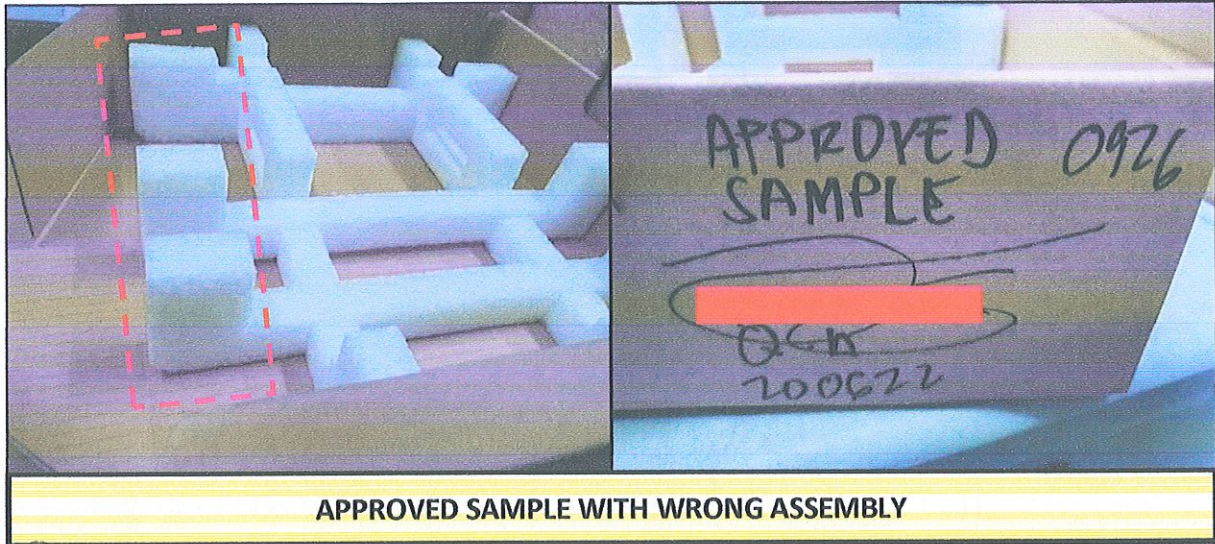
DIRECT CAUSE PROCESS/MATERIAL	W1- The Part-B & C chamfer located on left side during assembly, instead on right side.
	W2- Operator Rely the assembly base on Approved Sample of QA, based on Standard.
	W3- The approved sample is wrong assembly.

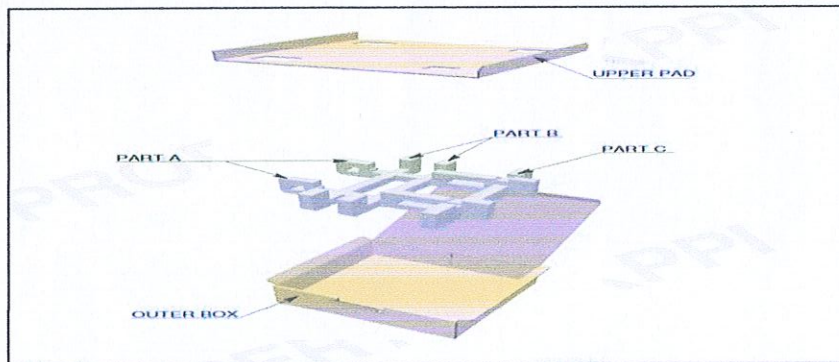
INDIRECT CAUSE PROCESS/MATERIAL	W1- QA approved the sample with wrong assembly.
	W2- Operator make a sample with wrong position of chamfer.
	W3- The position of Chamfer in the drawing is not clear.

Indicate the clear instruction of chamfer position in the drawing.

Orientation and awareness to operator regarding checkpoint of this item during assembly.

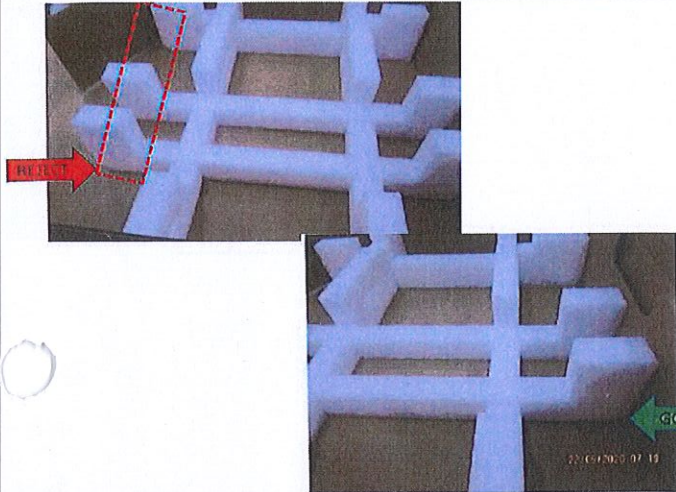
WRONG ASSEMBLY

Chamfer should be located on the right part

Chamfer was located on the left side

~ The QA Inspector approve the sample w/ wrong chamfer positioning since in the assembly drawing it is not visible

~ The assembly operator did the wrong the assy because the sample was approved by QA, it was approved because the positioning of chamfer is not visible in the drawing

Design / Tools	1. Propose to change the view of the assembly drawing to let the QA and Production see the chamfer and phasing of components after assembly 2. Provision of " JIG " as pattern of QA inspector during approval of the item	A. Vergara 20 06 26
----------------	---	------------------------

~ Change the view of the assembly drawing
~ Provision of dig
