KANEPACKAGE PHILIPPINE INC.

INVESTIGATION REPORT FORM (IRF)
☒ Inhouse Detection

Customer	EMORI	Attention To	Mr. Gerald De Guzman / Ms. Weena Apalla
Item Code	HP33D1010	Department	PRODUCTION
Item Description	CARTON BOX	Date of Detection	20 06 24
Job Order Number	WO-20-M-00748-23	Section Detected	QA - SCREENING

INVESTIGATION REPORT FOR MISALIGN GLUE OF EMORI HP33D1010

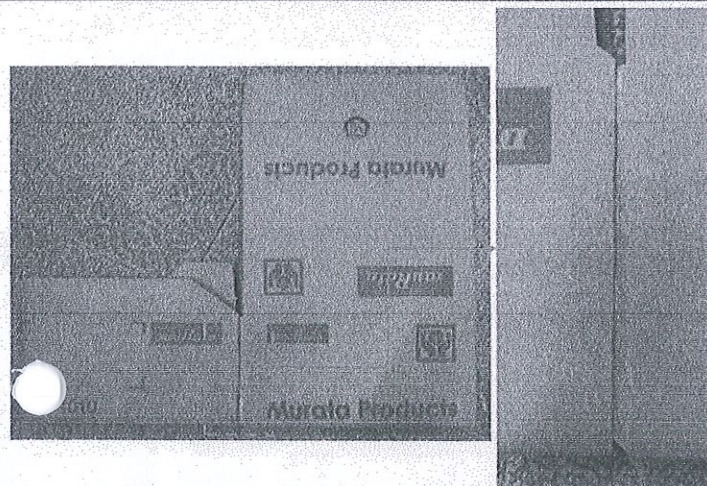
Lot Quantity (pcs.)	Reject Quantity (pcs.)	Reject Percentage
1,500	57	3.80%

MISALIGN GLUE

Bottom part of the item should be align

The bottom part is not align

- 2-3mm MISALIGN GLUE IS WITHIN TOLERANCE
- THE CREASING LINE OF LOWER FLAP IS NOT SO VISIBLE.

~ The bottom creasing was not aligned because the operator aligned the creasing on the upper part (height difference is 2mm)

DIRECT CAUSE PROCESS/MATERIAL	W1- The lower flap glue tab is misalign of 2-3mm and within tolerance.
	W2- The effect of 2-3mm misalign glue in 1st gluing process is visible only during 2nd gluing process.
	W3- There is an effect to the lock of bottom part upon checking in 2nd gluing process.
	W1- The creasing line of lower flap for this item is not so visible during 1st gluing process.
	W2- Unlike to D2000 & D2200 this item have no creasing matrix in lower flap, because the process of this item is in Diecut S1700. (Consume an Hour of downtime if the items have creasing matrix in Diecut S1700 or S1400)

~ Machine transfer from S1700 to ETERNA
~ Put Nick mark as alignment reference

1. Conduct pre-folding of lower flap during 1st gluing process to make it visible and easy to align.			
PIC:	Production	TARGET DATE:	If selected corrective action

2. Transfer the process of this item in Eterna and use separate plate for creasing matrix in lower flap.			
PIC:	Production	TARGET DATE:	If selected corrective action
