# KANEPACKAGE PHILIPPINE INC.

## INVESTIGATION REPORT FORM (IRF)

Customer	CANON
Item Code	RJ1-0921
Item Description	CASSETTE ASSY OUTER BOX
Job Order Number	WO-F-20-094-1

## INVESTIGATION REPORT FOR FLAP GAP OF CBMP RJ1-0921 CASSETTE ASSY OUTER BOX

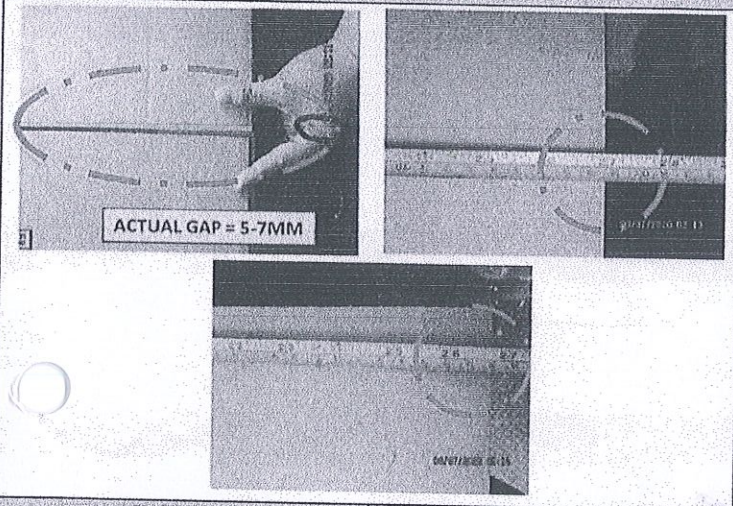
FLAP GAP

Flap should be closed and no gap

Upper flap and lower flap has a gap of 5~7mm

THE END DIMENSION EXCESS  
BY 3mm

~ Based on the actual sample dimension, all measure-  
ments are good / within tolerance.  
~ The inner dimension of the item increase to  
3mm (from 501mm req. to 504mm) and causes  
flap gap

~ Orientation to EQOS Operators & QA Patrol  
~ change design from 2joints to 1joint

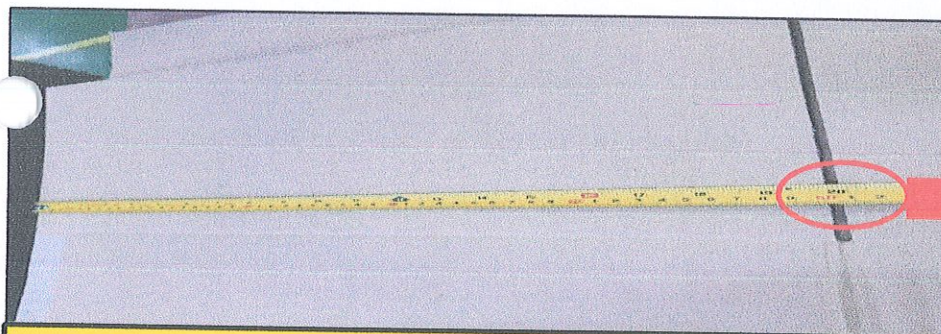
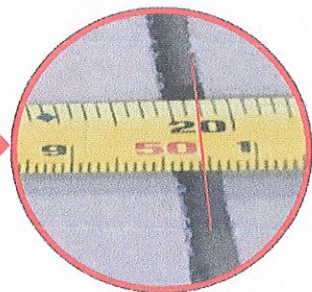
<b>DIRECT CAUSE PROCESS/MATERIAL</b>	<b>W1-</b> The end dimension of box is excess of 3mm that caused Flap Gap.
	<b>W2-</b> Possible during Eqos process the sheets move in to the Left/Drive side, because 2-joints boxes don't have 10mm excess in the length dimension for the gripping of suteban.
	<b>W1-</b> Even the 3mm excess in the end dimension is within tolerance, but during box assembly the effect is Flap Gap.

**The end dimension of boxes are excess of 3mm (504mm)**

<b>INDIRECT CAUSE PROCESS/MATERIAL</b>	<b>W1-</b> Operator proceed to mass production.
	<b>W2-</b> Trial run approved by QA Patrol.
	<b>W3-</b> Operator didn't know the effect of 3mm excess in the end dimension. And cant conduct box form checking because item is 2-joints and not yet glued.

Conduct study on how to eliminate the materials movement in eqos specially 2-joints boxes, because unlike to 1-joint there is 10mm excess in length dimension for the gripping of suteban but in 2-joints it is not applicable.			
<b>PIC:</b>	<b>3pm team</b>	<b>TARGET DATE:</b>

Orient the Eqos operator and QA Patrol that even 3mm excess in the end dimension is within tolerance the effect during box assembly is Flap Gap.			
<b>PIC:</b>	<b>PRODUCTION/QA</b>	<b>TARGET DATE:</b>	<b>for Production 200716</b>
