**KANEPACKAGE PHILIPPINE INC.**

INVESTIGATION REPORT FORM (IRF)☒ Inhouse Detection☐ Customer Claim

Control No.: 249

INVESTIGATION REPORT FOR BURSTING OF EMORI HP01D2000 CARTON BOX

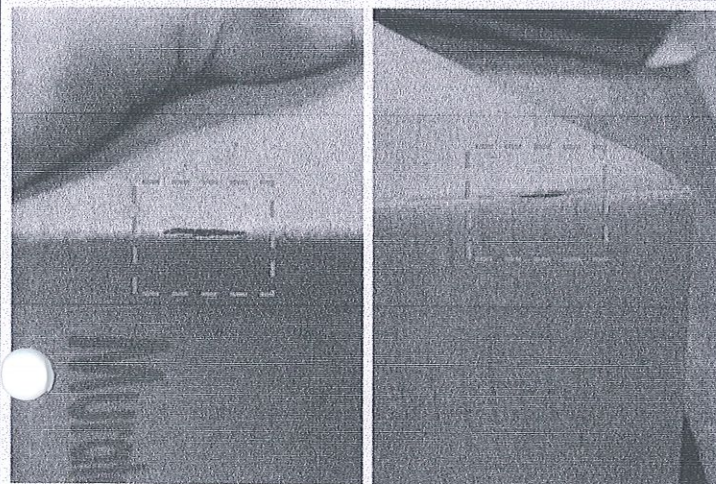
ILLUSTRATION OF THE PROBLEM

BURSTING

Bursting should not be visible and should not penetrate on the other side

Bursting occurs on 1 portion only and visible from rough surface to smooth surface

- CREASING MATRIX ACCIDENTALLY
DETACHED AND MOVED THAT CAUSED BURSTING

Replacement of creasing matrix on the steel plate

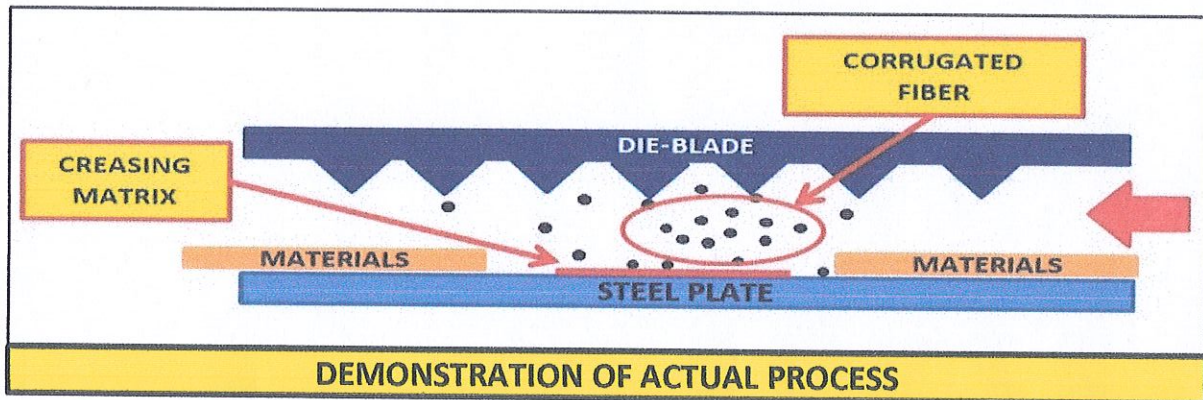
The creasing matrix attached on the steel plate was detached because the fibers accumulate on the steel plate

DIRECT CAUSE PROCESS/MATERIAL	W1- The creasing matrix in the lower flap accidentally detached and moved that caused bursting.
	W2- Naturally there is corrugated fiber came from the cutting portion of this item. The corrugated fiber accumulate in the Steel Plate where the creasing matrix attached and because of that, possible that the adhesive of creasing matrix become weak and at the same time the materials always hit the creasing matrix during process why it was detached and moved.

Immediate replace the Detach creasing matrix and check the condition of other creasing matrix attached in the Steel Plate.			
PIC:	PRODUCTION	TARGET DATE:	200715
Sort the items and separate the affected of bursting.			
PIC:	PRODUCTION	TARGET DATE:	200715
