KANEPACKAGE PHILIPPINE INC.

INVESTIGATION REPORT FORM (IRF)
☒ Inhouse Detection

Customer	EPSON IJP	Attention To	Mr. Gerald De Guzman / Ms. Weena Apalla
Item Code	5150864-01	Department	PRODUCTION
Item Description	INDIVIDUAL BOX	Date of Detection	20 07 22
Job Order Number	WO-DRS-20-L-0055-44	Section Detected	QA - IN LINE

INVESTIGATION REPORT FOR BURSTING OF EPSON IJP 5150864-01 INDIVIDUAL BOX

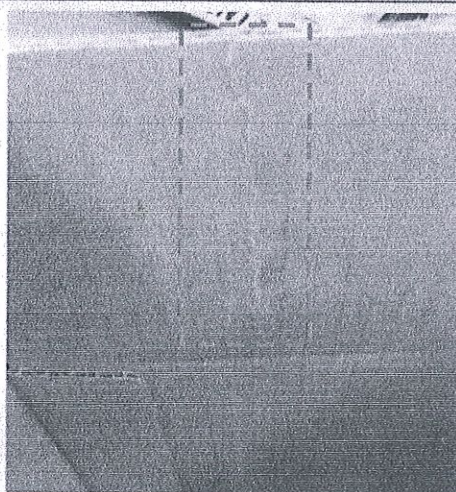
BURSTING

No occurrence of bursting on the item

Occurrence of bursting inside the box

THE CORRUGATED TRIMMING DID NOT EJECT
OR STUCK UP IN THE FEEDER STRIPPER.

occurrence of additional pressure from the
stripper of the item, because the scrap was
stuck on the stripper

Monitor the stripper, if the scrap stuck on the strip-
per the operator should stop the machine to remove
the scrap

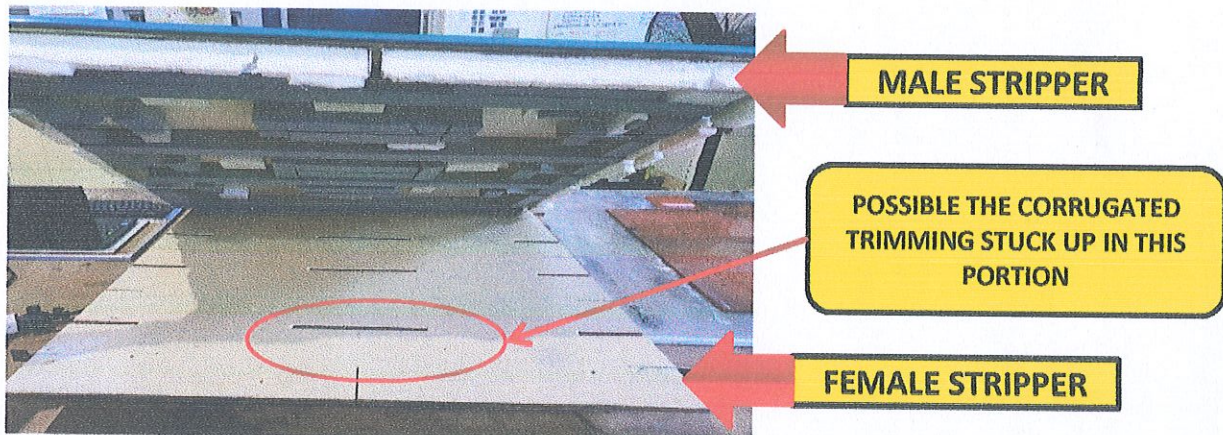
DIRECT CAUSE PROCESS/MATERIAL	W1- Possible that there is corrugated trimming did not eject or stuck up in the female stripper.
	W2- Due to corrugated trimming stuck up in the female stripper and the pressure during impression of male stripper to female stripper, the effect of this in the items is bursting.
	W1- Another factor that there is bursting in raw materials before the process.

INDIRECT CAUSE PROCESS/MATERIAL	W1 - Operator did not notice the bursting, because only sampling are required after the QA patrol approved the trial run.
--	---

Ask for the advice of ME if there is possible improvement in stripper blade, because operator notice that this stripper blade is prone in stuck up of corrugated trimming.
