**KANEPACKAGE PHILIPPINE INC.**

**INVESTIGATION REPORT FORM (IRF)**
☒ Inhouse Detection

Customer: EPSON IJP  
 Item Code: 5150863-01  
 Item Description: OUTER BOX  
 Job Order Number: WO-DRS-20-L-0055-65

## INVESTIGATION REPORT FOR PEEL OFF OF EPSON IJP 5150863-01 OUTER BOX

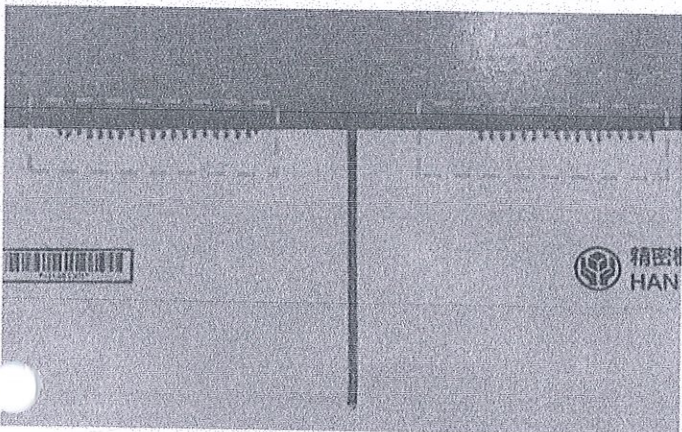
PEEL OFF

No Peel-off on the flap

With peel-off on the flap

- CORRUGATED BOARD HIT THE FEED GATE THAT CAUSED PEEL OFF BECAUSE MAT'S 15' WARP

The feedgate of the machine scratched the materials because the condition of the affected materials are warp

used of weight jig to minimize the warp of the materials

Continues implementation of using paper weight Jig and recondition of warp materials.			
<b>PIC:</b>	<b>PRODUCTION, QA &amp; WAREHOUSE</b>	<b>TARGET DATE:</b>	<b>200730 (PRODUCTION ORIENTATION)</b>

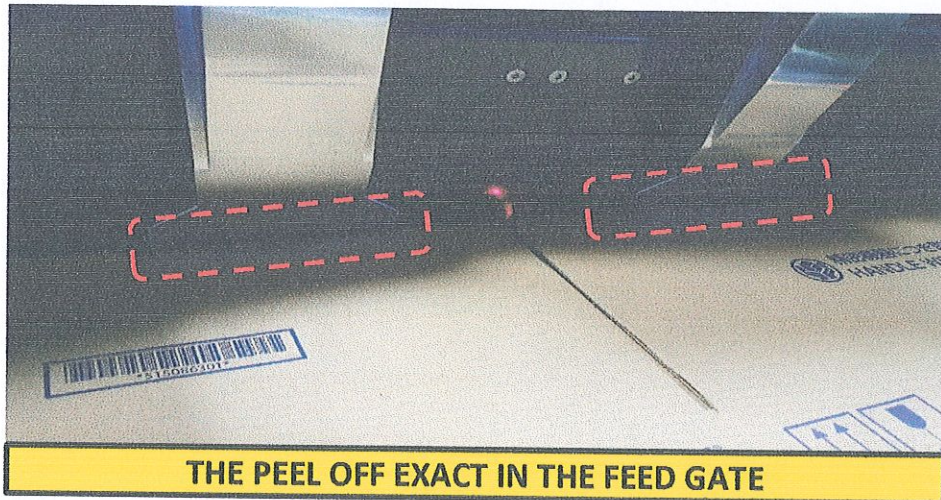
<b>DIRECT CAUSE</b> PROCESS/MATERIAL	W1- Corrugated board hit the feed gate that caused peel off.
	W2- It was happen only when the corrugated board materials is warp.
	W3- Possible that there is random of warp materials issued in Eqos.

<b>INDIRECT CAUSE</b> PROCESS/MATERIAL	W1- Operator didn't notice the warp materials because this item is one time running with big quantity. (3 JO's with total quantity of 3,024pcs)
	W1 - Possible the occurrence is randomly and due to machine speed of 120bpm / Skip on mode why the operator didn't notice the peel off during mass production.

Separate and immediate inform the Production Leader in-charge for the disposition, once they encountered warp materials or peel off during sampling.			
<b>PIC:</b>	<b>PRODUCTION</b>	<b>TARGET DATE:</b>	<b>200730 (ORIENTATION)</b>
