KANEPACKAGE PHILIPPINE INC.

INVESTIGATION REPORT FORM (IRF)

INVESTIGATION REPORT FOR MISALIGN SLOT OF EPSON IJP 5150863-01 OUTER BOX

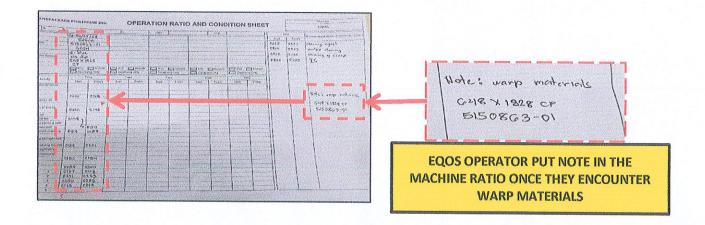
W1- Based on investigation Eqos operator encounter random of warp materials of 648 X 1828 CF

W2- They notice that the materials randomly bump in the roller near in the slotting unit of Eqos.

W3 - Once the warp materials bump the machine roller it caused delay timing of materials and the possible problem is misalign Print & misalign Slot.

Continues the recondition and usage of Paper weight Jig.					
PIC:	WAREHOUSE & QA	TARGET DATE:	ON-GOING		
	Separate and recondition	once the operator encounter w	arp materials.
