**KANEPACKAGE PHILIPPINE INC.**

**INVESTIGATION REPORT FORM (IRF)**☒ Inhouse Detection☐ Customer Claim

| Item Description | CARTON BOX | Date of Detection | 20 09 10 |

## INVESTIGATION REPORT FOR LINE MARK OF EMORI HP01D2200C CARTON BOX

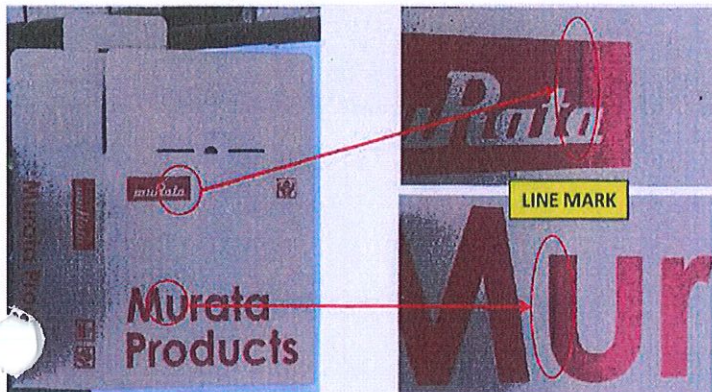
LINE MARK

W/ line mark on the logo

- Ink from the anilox roller got contaminated because the stuck ink fell down on the roller. The dried ink was not removed from the machine

| <b>DIRECT CAUSE<br/>PROCESS/MATERIAL</b> | <b>W1-</b> There is dried ink left in the anilox cover that can't clean during "AUTO WASHUP" or Automatic Anilox Cleaning.<br>(The anilox cover cleaning schedule is during Half and Month End maintenance) |
| | <b>W2-</b> That dried ink in the anilox cover accidentally fell down in the anilox during mass production. |
| | <b>W3-</b> Dried ink made stain in the anilox, then transferred in the cyrel. |

- Clean the anilox roller once the it was contaminated  
- Stop immediately the machine once it was encountered

| <p>This problem is inherent even in the long way printing before and we cant clean the anilox cover daily because its take long hours.</p> <p>The corrective action we can do is to orient the operator once they encounter or trap this problem immediately stop the process and clean the anilox by " AUTO WASHUP".</p> | | | |
