INVESTIGATION REPORT FORM (IRF)

INVESTIGATION REPORT FOR MISALIGN SLOT OF EPSON IJP 5149643-01 OUTER CARTON BOX

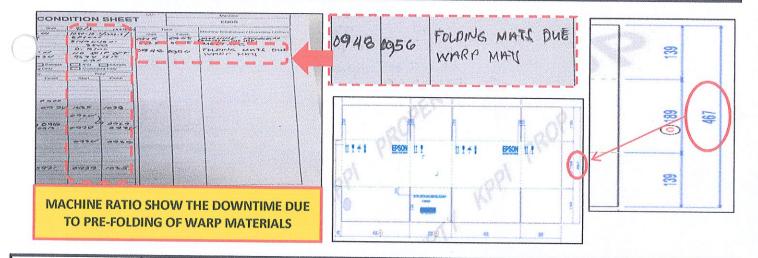
W1-Base on investigation Eqos operator conduct free folding of flap in Raw materials before feeding in Egos. W2- They trap random of misalign slot because the sheet bump in the roller during mass production. **DIRECT CAUSE** W3 - There is a random of warp material found. PROCESS/MATERIAL W1- The other factor is the height of this item is only 467mm vs 500mm distance of roller to roller of Egos machine. W2- This condition of item with below 500mm height is prone to misalign slot because there is interval gripping of roller to item happen.

INDIRECT CAUSE W1- Possible occurrence of misalign slot are randomly and due to machine speed 110bpm with Skip Off mode why the operator did not trap all the affected.

Continues the pre-folding once the operator encountered random of warp materials in RSC box raw mats with creasing.

Transfer this item in diecut with 2 outs in diecut blade. PIC: SALES **TARGET DATE:**
