**KANEPACKAGE PHILIPPINE INC.**

INVESTIGATION REPORT FORM (IRF)☒ Inhouse Detection☐ Customer Claim

Control No.: 295

INVESTIGATION REPORT FOR MISALIGN PRINT OF NIDEC SUBIC VR-D RYZ000003 BOX

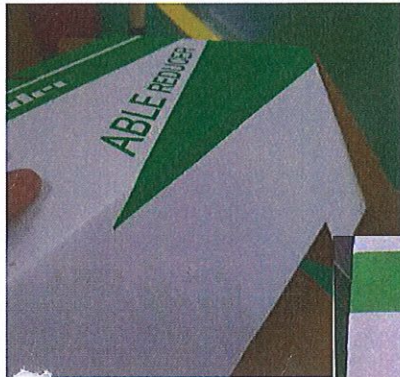
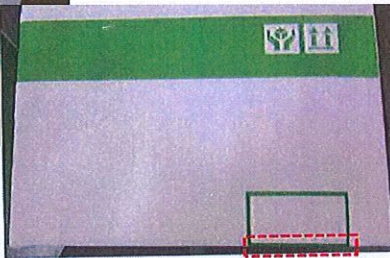
ILLUSTRATION OF THE PROBLEM

MISALIGN PRINT

±5mm printing tolerance

Print location move exceeded on the tolerance

— STACKING HEIGHT LIMIT IN FEEDER
IS MORE THAN 250mm

Delay feeding timing in the machine because of
heavy piling @ feeding unit because the stacking
height of the item is > 250mm

DIRECT CAUSE PROCESS/MATERIAL	W1- Operator notice that they need to consider the height limit of materials in feeder during mass production.
	W3 - They encountered misalign print when the stacking height of materials in feeder is more than 300mm.

Stacking height should be less ~~25~~ than 250mm

Set the 250mm Stacking Height Limit in Eqos feeder for this item and monitor the effectiveness.
