**KANEPACKAGE PHILIPPINE INC.**

**INVESTIGATION REPORT FORM (IRF)**
☒ Inhouse Detection

Customer	NIDEC SUBIC	Attention To	Mr. Gerald De Guzman
Item Code	VR-C RYZXD000002	Department	PRODUCTION
Item Description	PAD B	Date of Detection	20 09 27
Job Order Number	WO-SO-IPD-1343-4	Section Detected	QA - SCREENING

## INVESTIGATION REPORT FOR BURSTING OF NIDEC SUBIC VR-C RYZXD000002 PAD B

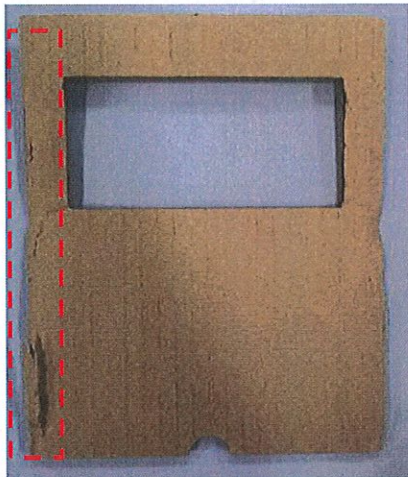
Nature of Defect:

BURSTING

No presence of bursting on the surface

W/ Bursting on the rough surface

- BRITTLE OR WEAK KRAFT LINER MATERIALS.

> Brittle materials  
 > Too much impression applied on the corrugated boards because the cushion is gray ejector.

> Change cushion from gray ejector to eperan cushion

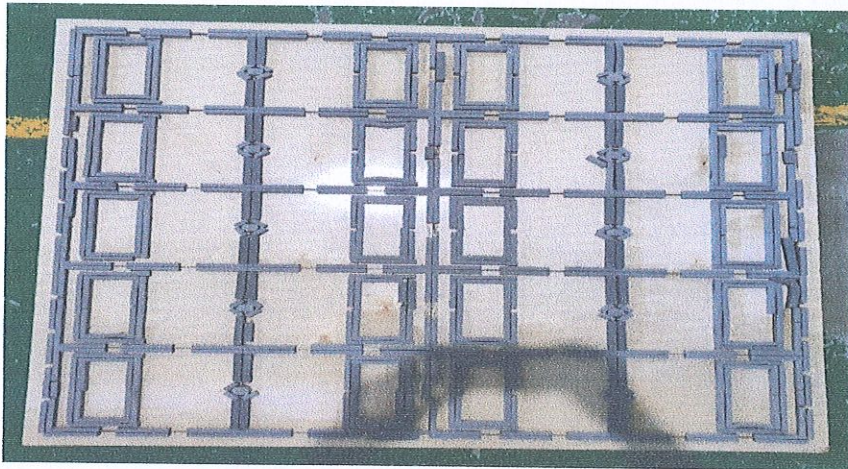
<b>DIRECT CAUSE</b> PROCESS/MATERIAL	<b>W2-</b> We didn't find abnormality in diecut blade layout because it's within standard.
	<b>W1-</b> Possible that there are random of brittle or weak Kraft Liner in raw materials issued.
	<b>W3 -</b> Brittle or weak Kraft liner specially if CB-flute materials is prone in bursting.

<b>INDIRECT CAUSE</b> <b>(OUTFLOW)</b> PROCESS/MATERIAL	<b>W1-</b> Operator did not trap the bursting during sampling because possible its occurs randomly.
---	---

Monitor the next running of this item to find out if we need to adjust the layout of die-blade  
depend to the materials condition.
