**KANEPACKAGE PHILIPPINE INC.**

**INVESTIGATION REPORT FORM (IRF)**☒ Inhouse Detection☐ Customer Claim

## INVESTIGATION REPORT FOR DAMAGE PRINT OF NIDEC SUBIC VR-D-RYZXD000003 BOX

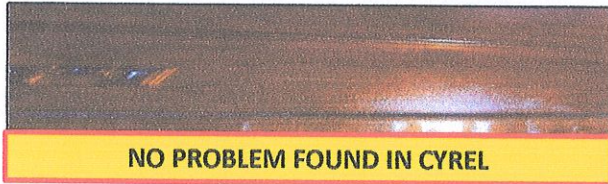
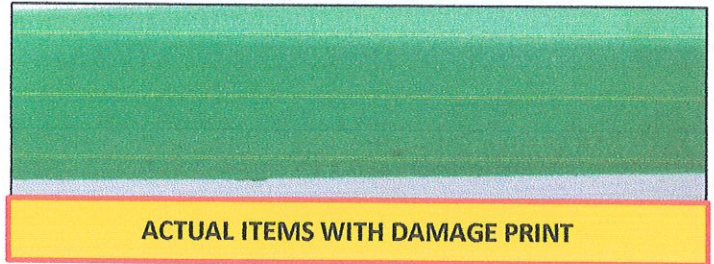
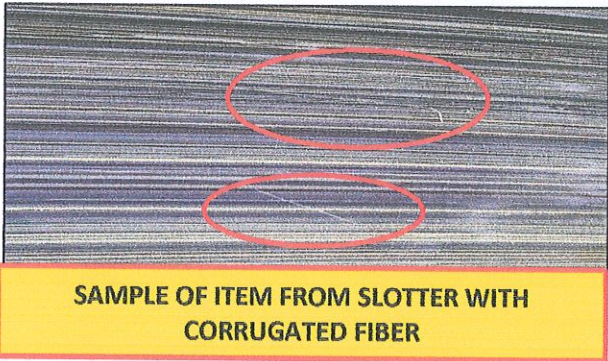
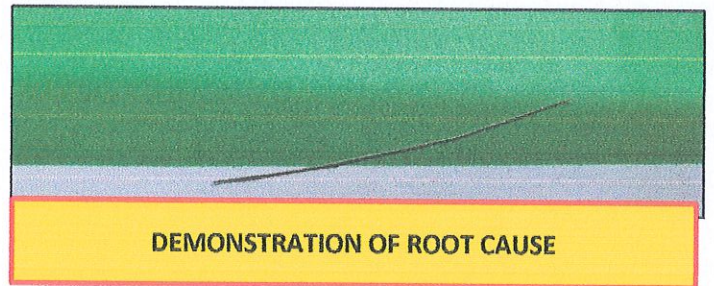
Damaged Print

W/ damaged on the solid print

- CORRUGATED FIBER STICK IN THE CYREL

The fibers leaved a mark on the materials since fiber was attached on the rubber die, the long fiber was inherent to corrugated boards since it was came from slitting process

<b>DIRECT CAUSE PROCESS/MATERIAL</b>	<b>W1-</b> This item underwent Slotter process before the printing process in Eqos.
	<b>W2-</b> Corrugated board is prone in corrugated fibers specially if undergone cutting in Slotter process.
	<b>W3-</b> Possible that there is a corrugated fibers that was stuck in the cyrel during mass production because the occurrence is in one portion only.

<b>INDIRECT CAUSE (OUTFLOW) PROCESS/MATERIAL</b>	<b>W1-</b> Eqos operator, QA, ME and Production Leaders monitored the item during the process since this is IPD. The print is critical that time and this is an urgent process because Nidec will pick up the item that same night.
	<b>W2-</b> Several problem was encountered at that time, but all are in focused with the 4mm misalign print trapped in the middle of mass production and failed to noticed the foreign material in the cyrel causing damaged print.

> From design sheets to exact sheets to prevent fibers.

> On the next running of any Nidec Subic White Kraft item, clean all sides of the palletize board to remove excess fiber. > Will include this reject on the checkpoints during mass production.			
<b>PIC:</b>	<b>PRODUCTION</b>	<b>TARGET DATE:</b>	<b>NEXT RUNNING OF ANY NIDEC SUBIC WHITE CRAFT</b>
