**KANEPACKAGE PHILIPPINE INC.**

INVESTIGATION REPORT FORM (IRF)☐ Inhouse Detection☒ Customer Claim

Customer	SANYO DENKI
Item Code	01035309-01
Item Description	INNER PAT
Job Order Number	WO-TO-IPD-447-9

BURSTING

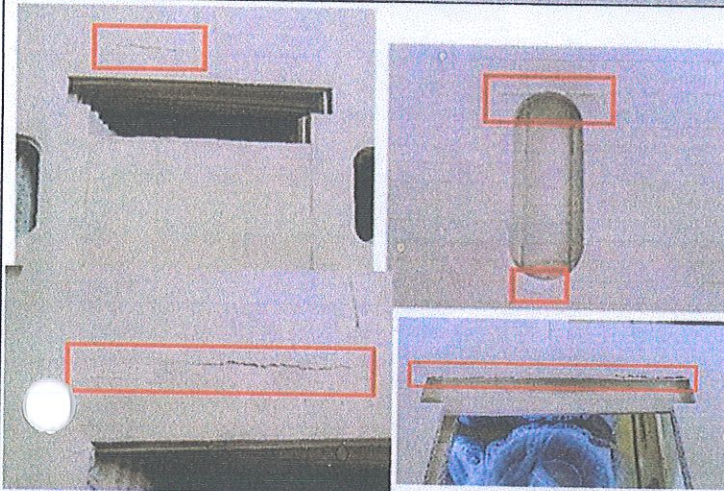
ILLUSTRATION OF THE PROBLEM

No bursting on the rough surface of the item

W/ bursting on the rough surface

- BRITTLE OR WEAK KRAFT LINER MATERIALS.

PRD: Brittle materials & Too much impression applied on the corrugated boards because the cushion is gray ejector.
QA: The defect was judged as good because the QA Inspector refer on the defect limit criteria that was intended for UPS division only

Re-layout of die-blade using Eperan cushion to avoid the bursting.			
PIC:	PRODUCTION	TARGET DATE:	201029 (Done)

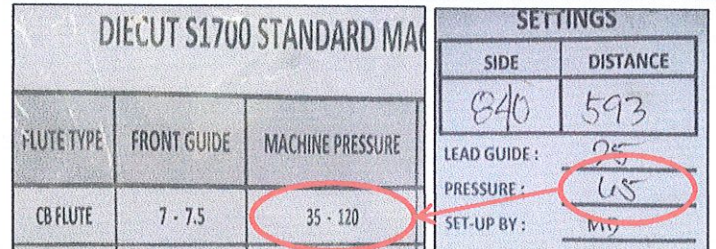
DIRECT CAUSE PROCESS/MATERIAL	W1 - Blade layout is within standard using gray sponge.
	W2 - Possible the brittle or weak Kraft Liner is the cause of bursting.
	W3 - Brittle or weak Kraft liner specially if CB-flute materials is prone in bursting.

USED PRESSURE IS WITHIN THE STANDARD

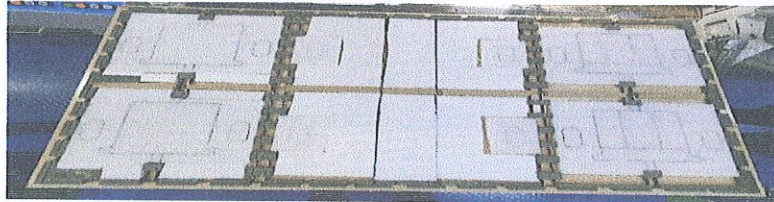
TRIAL WITHOUT BURSTING OCCURRENCE

QA INSPECTION REPORT SHOW NO BURSTING
DEFECT FOUND

Check the effectiveness of using Eperan Cushion.			
PIC:	PRODUCTION	TARGET DATE:	201029 (Done)
