1835							
KANEPACKAGE PHILIPPINE INC. No. 5 Ring Road LISP II, Brgy, La Mesa, Calamba City, Laguna Telephone No. (049) 545-7166 to 69 Fax No. (049) 545-6302			INVESTIGATION REPORT FORM (IRF)				
			Inhouse Detection Customer Claim Control No.: 329 Date Issued: 20 11 19				
Customer	omer EPSON IJP			Attention To Mr. Gerald De Guzman

INVESTIGATION REPORT FORM (IRF)

INVESTIGATION REPORT FOR BURSTING OF **EPSON IJP 5150864-01 INDIVIDUAL BOX**

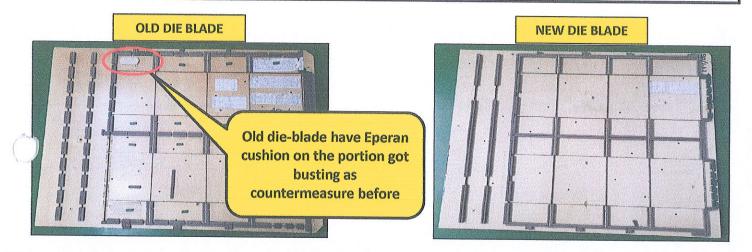
#01700					Date Conducted: 20 11 20 PIC: A. VERGORO		
Identified Rootcause					Recommendation		
The moterials cannot withstand the impact of the die-cut blade since they are brittle

DIRECT CAUSE PROCESS/MATERIAL

- W1- Operator used the new die-blade because the old die-blade is already worn-out.
- W2- For some inexplicable reason, like in the old die-blade before there is random occurrence of bursting on the same portion.

Put Eperan cushion to the affected area, like what they do in the old die-blade.
