**KANEPACKAGE PHILIPPINE INC.**

INVESTIGATION REPORT FORM (IRF)☒ Inhouse Detection☐ Customer Claim

Control No.: IRF-04-0009

Customer	CANON	Attention To	NOEMI CEPEDA
Item Code	RX1-4518-000	Department	KPLIMA-PRODUCTION
Item Description	Z10 CARTON	Date of Detection	07-Apr-22
Job Order Number	14374	Section Detected	KPFPIP

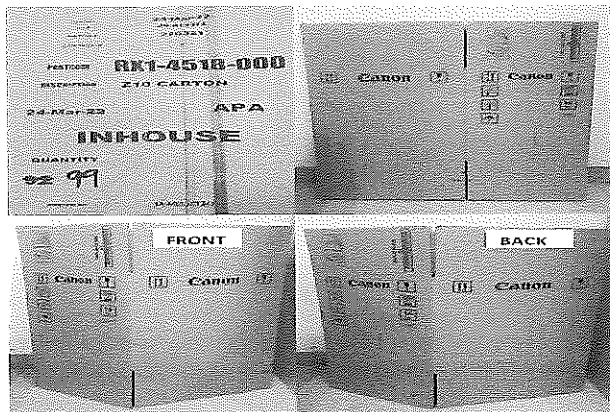
DOUBLE PANEL

DOUBLE PANEL (Both Panel B)

FINAL CONCLUSION									
OCCURRENCE ROOTCAUSE					OUTFLOW ROOTCAUSE				
Feeding of same panels from rework process due to weak application of melltite.									
IMMEDIATE ACTION: (Action to be done to contain/ temporary correct the problem found)					CORRECTIVE ACTION: (Actions to be done to ensure that the problem will not happen again)

Identified Rootcause	Recommendation
Mix of panels from the production "for rework items"	<ul style="list-style-type: none"> - To have trolley for rework items - Orientation for concerned operators regarding rework. and WI.

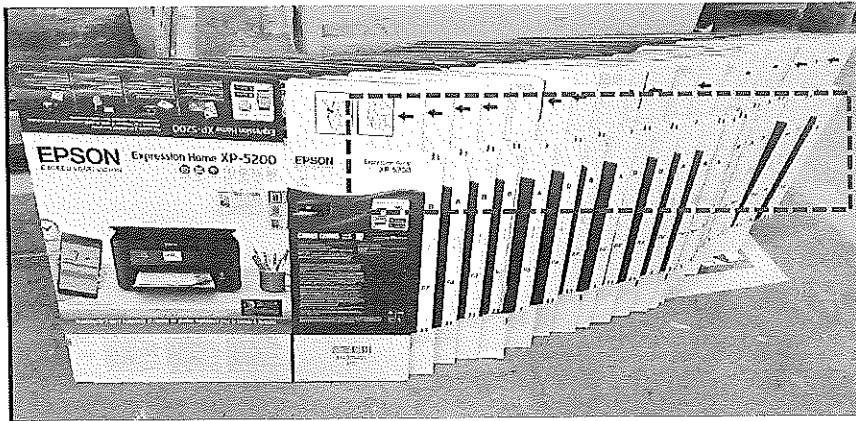
Sample of for rework items with mix up panels
