**KANEPACKAGE PHILIPPINE INC.**

INVESTIGATION REPORT FORM (IRF)☒ Inhouse Detection☐ Customer Claim

Customer: NIDEC SUBIC
Item Code: VR-B RYZX000001
Item Description: PAD B
Job Order Number: WO-SO-IPD-1486-17

INVESTIGATION REPORT FOR BURSTING OF NIDEC SUBIC VR-B RYZX000001 PAD B

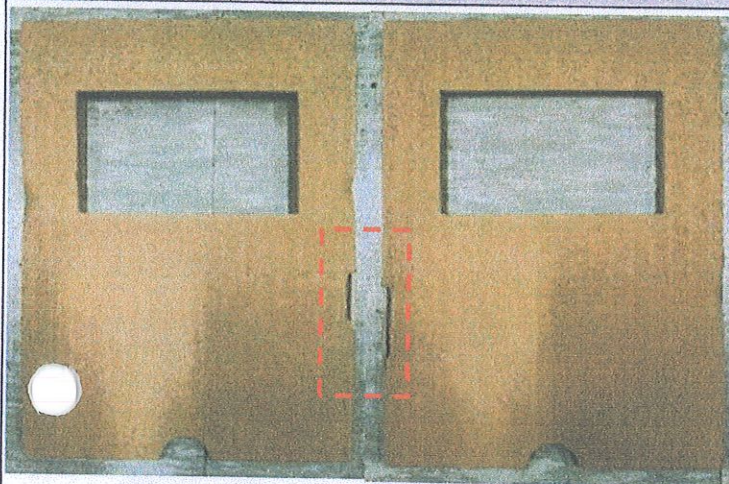
ILLUSTRATION OF THE PROBLEM

BURSTING

No bursting on the surface of the item

W/ bursting on the rough surface

- BRITTLE OR WEAK KRAFT LINER

> Brittle materials
> Tight impression of diecut blade to corrugated boards since the ejector used is gray sponge

Re-layout the die-blade using 13-15mm Eperan cushion, as one of the countermeasure in bursting.

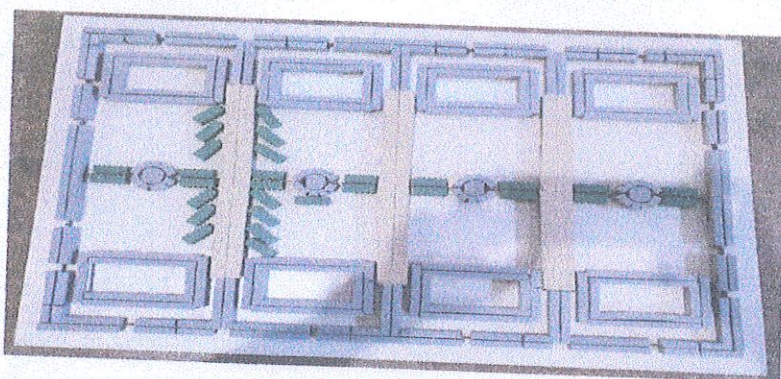
DIRECT CAUSE PROCESS/MATERIAL	W1- Blade layout is within standard using gray sponge.
	W2- Possible the brittle or weak Kraft Liner is the cause of bursting.
	W3 - Brittle or weak Kraft liner specially if CB-flute materials is prone in bursting.

INDIRECT CAUSE (OUTFLOW) PROCESS/MATERIAL	W1- Diecut operator proceed to mass production because trial run approved by ME.
	W2- Operator do some remedy if they encounter bursting.
	W3- Operator did not trap the bursting during sampling because possible its occurs randomly.
