**KANEPACKAGE PHILIPPINE INC.**

INVESTIGATION REPORT FORM (IRF)☒ Inhouse Detection☐ Customer Claim

Customer	SUBIC NIDEC
Item Code	VR-B RYZX000001
Item Description	BOX
Job Order Number	WO-SO-IPD-1436-1

INVESTIGATION REPORT FOR SPOT OF NIDEC SUBIC VR-B RYZX000001 BOX

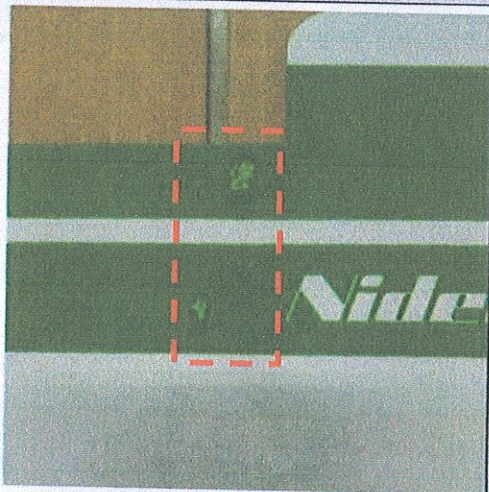
Nature of Defect:

SPOT

Actual:

W/ spot on the solid image

- CRACK IN WHITE KRAFT STUCK IN THE CYREL DURING MASS PRODUCTION

There was a material fiber stuck on the rubber plate because there was a cracking on the edge of the materials.

From common sheets to exact sheet

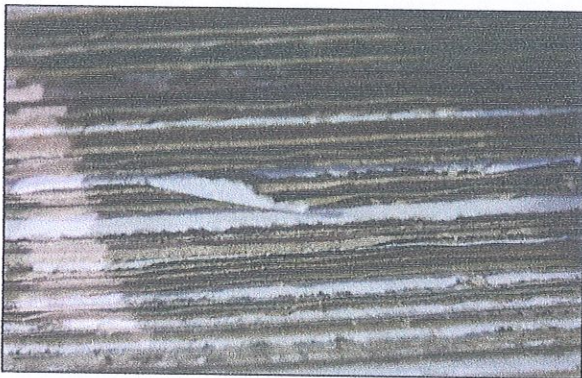
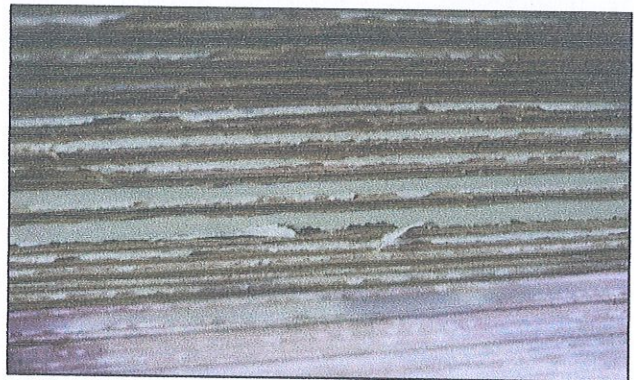
DIRECT CAUSE PROCESS/MATERIAL	W1- This item underwent Slotter process before the printing process in Eqos.
	W2- We notice that the white kraft is brittle and due to cutting mechanism of Slotter there are cracking happen in the white kraft
	W3- The crack in white kraft stuck in the cyrel during mass production because the occurrence is in one portion only.

INDIRECT CAUSE (OUTFLOW) PROCESS/MATERIAL	W1- Eqos immediate stop and clean the cyrel once they encountered spot.
	W2- Possible the operator did not notice the outflow because it was happen randomly.

Transfer of slotter process in Slotter Mexico in Superflex, because the cutting mechanism of Slotter Mexico is smooth like in vertical machine even the board is brittle. <i>Also will push exact sheet - will generate common sheets for all white Kraft</i>			
PIC:	SALES / MPD	TARGET DATE:	<i>Nathan November</i> <i>for Next PO.</i>
