# KANEPACKAGE PHILIPPINE INC.

## INVESTIGATION REPORT FORM (IRF)

Customer: NIDEC SUBIC  
Item Code: VR-D RYZXD000003  
Item Description: BOX  
Job Order Number: WO-SO-IPD-1486-7

# INVESTIGATION REPORT FOR MISALIGN PRINT/DIECUT OF NIDEC SUBIC VR-D RYZXD000003 BOX

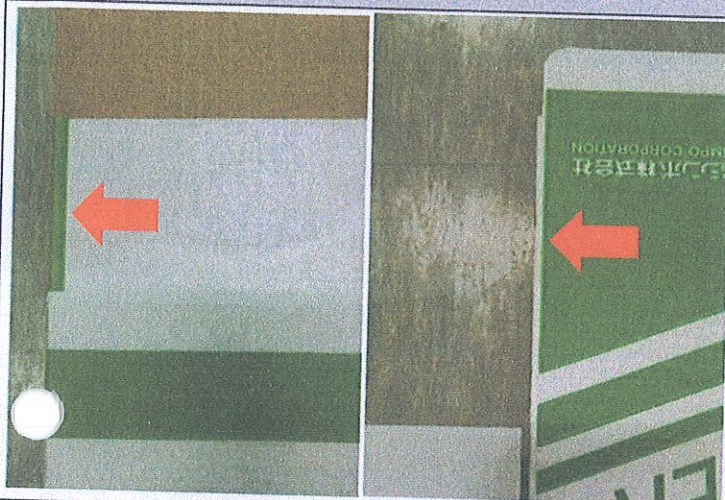
MISALIGN PRINT

Print tolerance is +/-5mm

Printing movement is 6 ~ 7mm

The diecut is offset by 6-7mm because the material is warp.

<b>DIRECT CAUSE</b> PROCESS/MATERIAL	W1- Based on investigation during Diecut S1700 process, operator encountered random of warp materials.
	W2- The standard setup of Diecut side guide is actual sheet size +3mm, but if the materials is warp the +3mm tolerance was loosed.
	W3- Possible the warp materials move lateral upon Diecut process that caused misalign.

Orient the Diecut operator to separate the affected item once they encounter random of warp materials, because the warp materials need different side guide setup or materials recondition.

- > Once encounter random of warp materials, separate the affected materials.
- > Adjust the side guide with +3mm tolerance base on materials warpage.
- > If the adjustment of side guide is not affected because still there is occurrence of misalign, the next countermeasure is to recondition the affected materials.
