**KANEPACKAGE PHILIPPINE INC.**

**INVESTIGATION REPORT FORM (IRF)**☒ Inhouse Detection☐ Customer Claim

Item Code: PRO2302G

# INVESTIGATION REPORT FOR BURSTING OF TERADYNE PRO2302G BOX

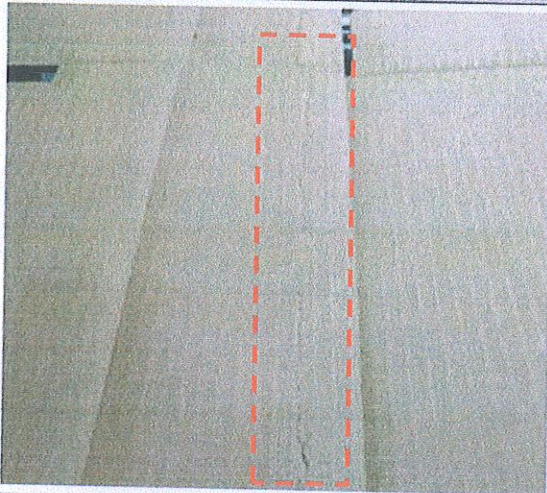
BURSTING

Bursting length is 520mm and located inside the item

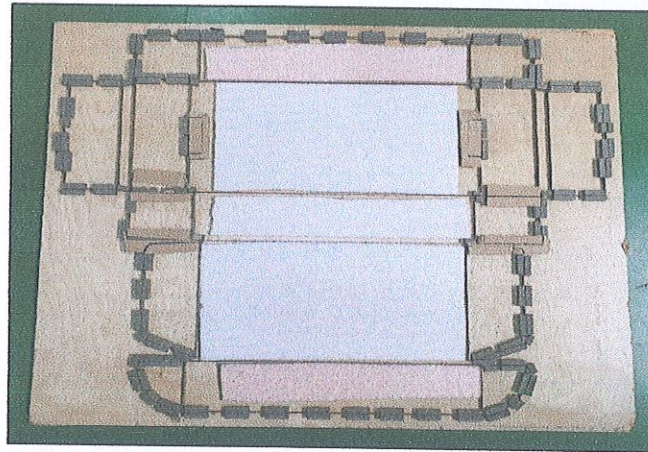
<b>DIRECT CAUSE</b> PROCESS/MATERIAL	W1- Die-blade already have Eperan cushion for the counter measure to bursting problem.
	W2- One of the factor to be consider is the compressed Eperan cushion due to machine compression, because upon verification the thickness of Eperan cushion in die-blade is 10mm and only 2mm higher than the 8mm cutting blade.
	W1 - Another factor to be consider is the brittle materials, because the items is existing and this is the first time we encountered outflow of bursting for this item.

<b>INDIRECT CAUSE</b> (OUTFLOW) PROCESS/MATERIAL	W1- Obviously in die-blade layout that the operator did some remedy to avoid bursting.
	W2- Operator did not trap the bursting during sampling because possible its occurs randomly.

- Replacement of Eperan cushion from 12mm to 14-15mm thickness.
- Monitor next running the effectiveness of 14-15mm thickness Eperan.

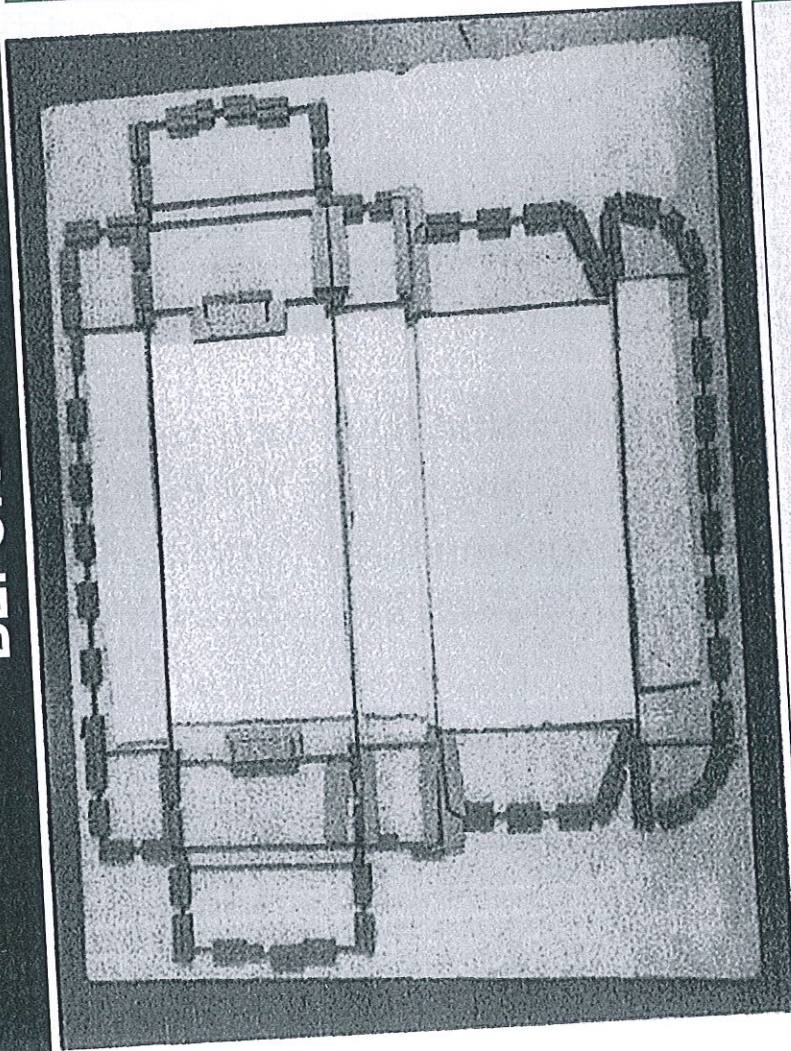
**BEFORE**

Thickness is  $\leq 10\text{mm}$
