**KANEPACKAGE PHILIPPINE INC.**

INVESTIGATION REPORT FORM (IRF)☒ Inhouse Detection☐ Customer Claim

Control No.: 354

INVESTIGATION REPORT FOR BURSTING OF TERADYNE ASSEMBLY BOX - RFMG

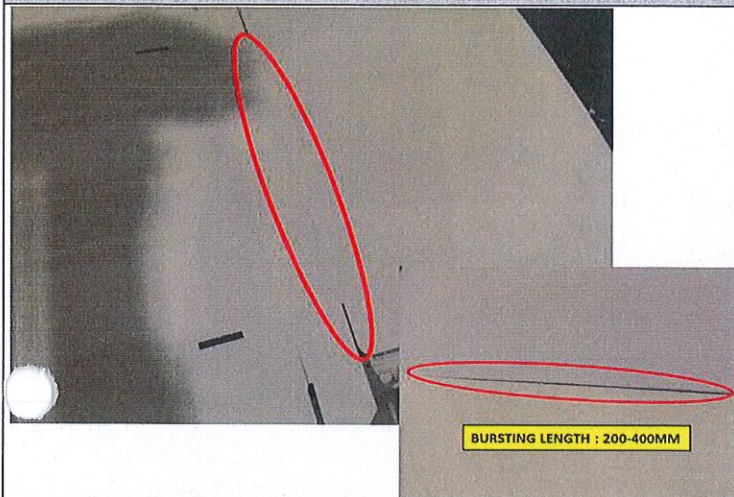
BURSTING

Bursting is good as long as it is visible and 50mm length only

Bursting length range is 200mm ~ 400mm

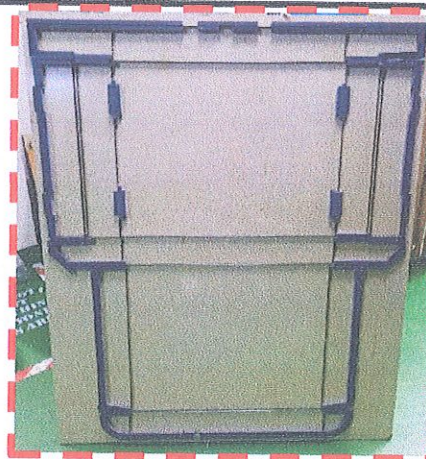
Tight impression of creasing rule because the
sponge attached on the wood is not enough to
oppose the force

DIRECT CAUSE PROCESS/MATERIAL	W1- New dieblade was used because the old blade was already worn-out.
	W2 - New sponge was used in layouting of the new blade which is less softer compared to the old sponge.
	W3- 12 mm hard sponge was used in blade layouting for 8 mm cutting blade.

New hard sponge was used in blade layout.

Replace the 12 mm hard sponge cushion with 12 mm Eperan cushion and monitor its effectiveness in the next processing.			
PIC:	TOOLING	TARGET DATE:	DEC. 21, 2020

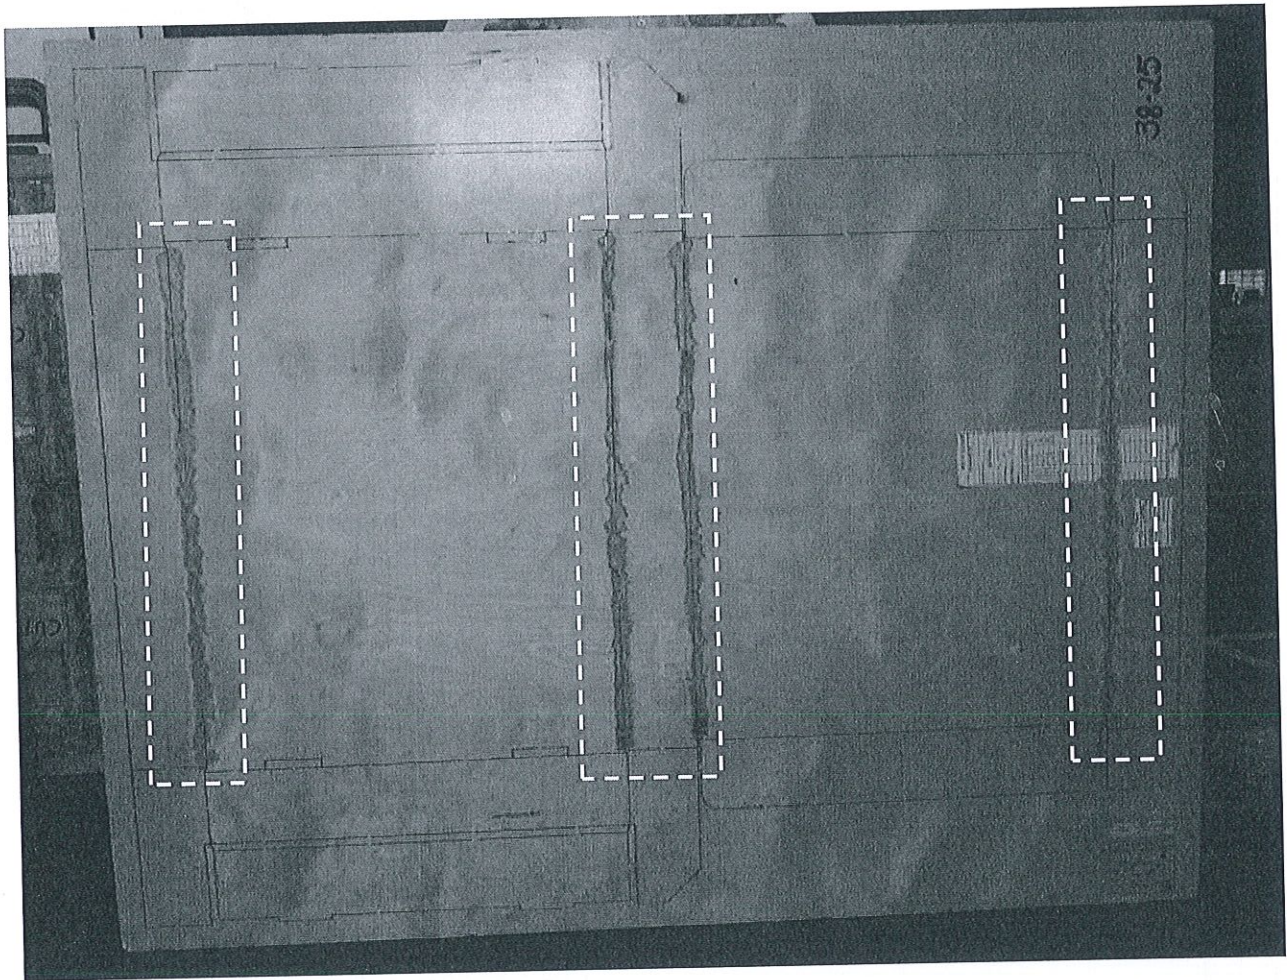
The 4 creasing rules of the die cut blade were grinded to prevent occurrence of bursting on the same location.

Grind the creasing rule of the die cut blade
