**KANEPACKAGE PHILIPPINE INC.**

**INVESTIGATION REPORT FORM (IRF)**☒ Inhouse Detection☐ Customer Claim

Customer	NIDEC SUBIC	Attention To	Mr. Gerald De Guzman
Item Code	VR-E	Department	PRODUCTION
Item Description	BOX	Date of Detection	21 02 17
Job Order Number	JO-21-IPD-00071-3	Section Detected	QA - SCREENING

# INVESTIGATION REPORT FOR POOR PRINT (SPOT/SCUM) OF NIDEC SUBIC VR-E BOX

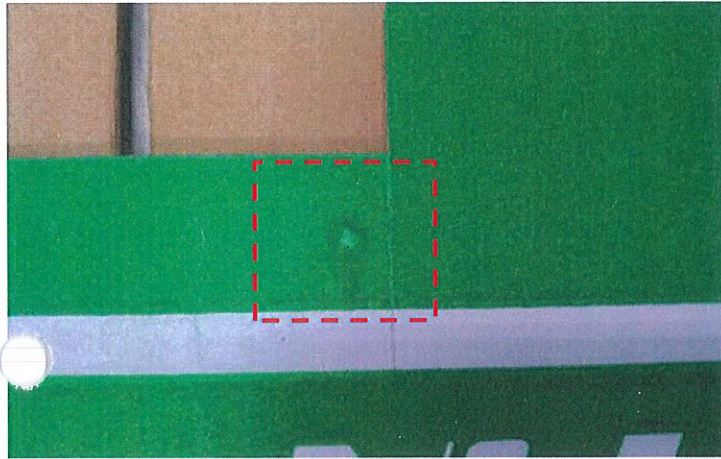
POOR PRINT (SCUM/SPOT)

Scum is not acceptable

W/ scum on the solid image

- PRINT MOVE DOWNWARD OF 4mm  
BECAUSE SHEET SIZE IS PHONE TO MOVEMENT  
OR BELOW 500mm.

> there was a fiber stuck on the rubber die  
because there was a cracking on the sheets

<b>DIRECT CAUSE PROCESS/MATERIAL</b>	<b>W1-</b> Due to the movement of Spot/Scum from different location we conclude that the problem is from corrugated fiber or crack white kraft.
	<b>W2-</b> Even we change the material to actual sheet we did not 100% sure that there is no corrugated fiber or crack white kraft in the raw materials.
	<b>W3-</b> The corrugated fiber or crack white kraft stick in the cyrel that caused spot/scum.

<input type="checkbox"/> Network of affected items if applicable? <input checked="" type="checkbox"/> - Orient the Eqos operator regarding this issue and get their idea on how to avoid this problem.			
<b>PIC:</b>	<b>PRODUCTION</b>	<b>TARGET DATE:</b>	<b>210222</b>
