**KANEPACKAGE PHILIPPINE INC.**

INVESTIGATION REPORT FORM (IRF)☒ Inhouse Detection☐ Customer Claim

Misalign Print

INVESTIGATION REPORT FOR MISALIGN PRINT OF SANYO DENKI 00415456-01 PACKAGE

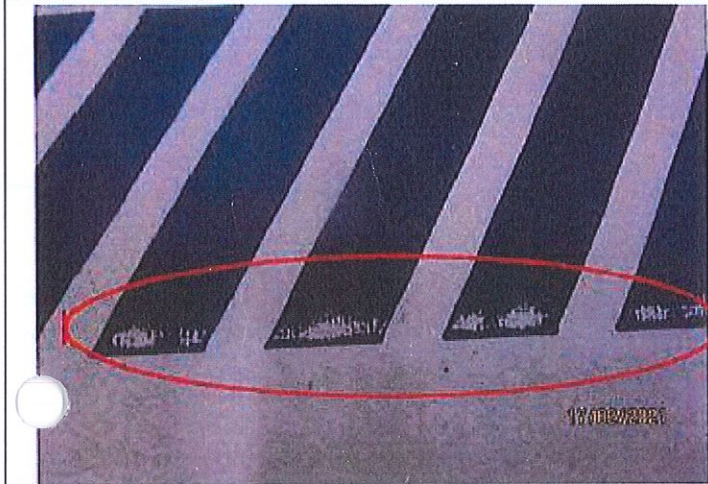
Requirement:Printing tolerance is $\pm 5\text{mm}$ **Actual:**

The solid image coincided on the creasing that causes poor print. Solid image distance from creasing is 10mm

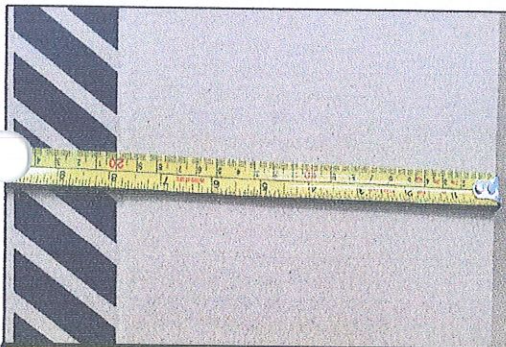
DIRECT CAUSE PROCESS/MATERIAL	W1- Based on the rejected sample print ^{MOV} downward of 4mm.
	W2- The 4mm movement is within the print tolerance, but because the print distance from the creasing line is only 10mm plus the 9mm mark of supplier creasing line its become more visible or sometimes cause of poor print.
	W3- Item is prone to movement vertically because the sheet size height is below 500mm.
	W4- Operator did not used Suteban.

REQUIREMENT: 204mm

- Put Suteban in this item next running.
- Standardize the usage of Suteban in all items to Eqos Work Instruction.

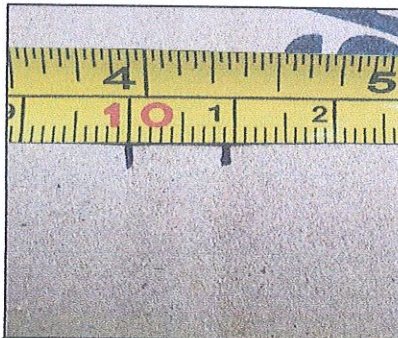
**MARK OF SUPPLIER
CREASING LINE: 9mm**

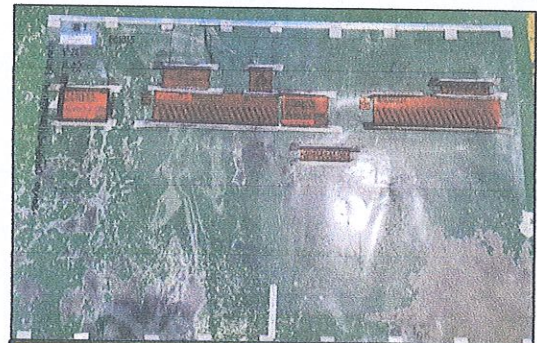
No Suteban in Mylar/Cyrel
