**KANEPACKAGE PHILIPPINE INC.**

INVESTIGATION REPORT FORM (IRF)☒ Inhouse Detection☐ Customer Claim

Control No.: 396

INVESTIGATION REPORT FOR MISALIGN PRINT OF NIDEC SUBIC VR-B BOX

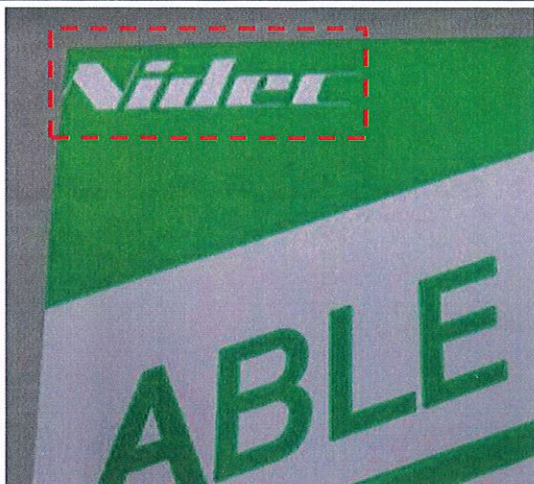
<input type="checkbox"/>	Major	<input checked="" type="checkbox"/>	Minor
Lot Quantity (pcs.)		Reject Quantity (pcs.)	Reject Percentage
932		113	12.12%
Nature of Defect:			
MISALIGNED DIE-CUT			
Requirement:			
Customer's logo should not be cut			
Actual:			
Cut Nidec Logo

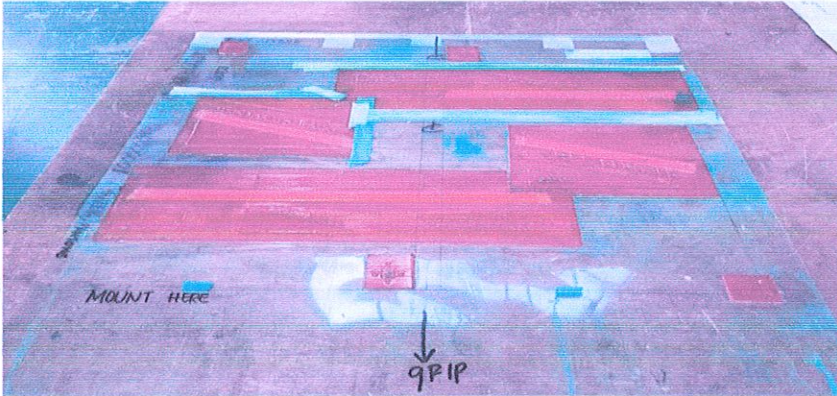
DIRECT CAUSE PROCESS/MATERIAL	W1- Operator in Eqos concern that the white kraft is prone to misalign due to slippery surface.
	W2- Possible that the sheet slide during printing since during checking of actual reject the print was slanted.

No Suteban in Cyrel Mylar because the sheet size is more than 500mm in height.

Put Suteban in both side of Cyrel Mylar for better grip of sheets even the sheet size is more than 500mm in height, since the white kraft according to Eqos operator is slippery why it is prone to misalign.

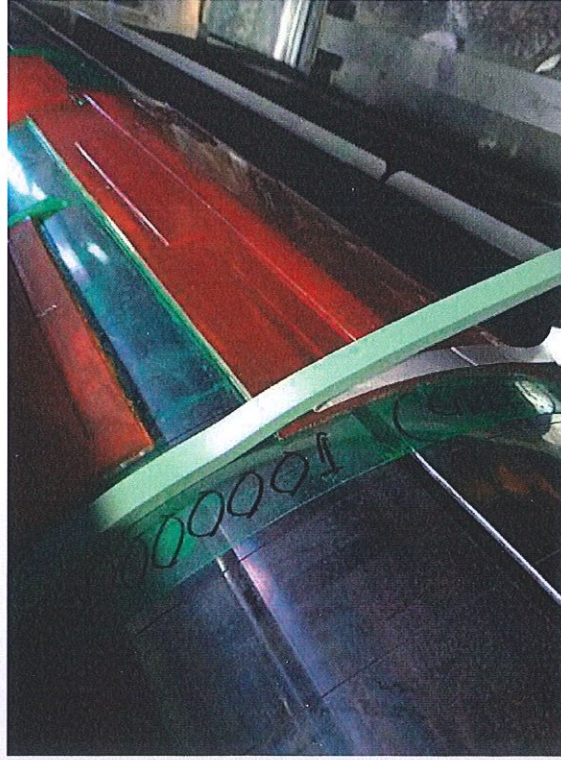
REMARKS: Sutureban was not mount end to end.

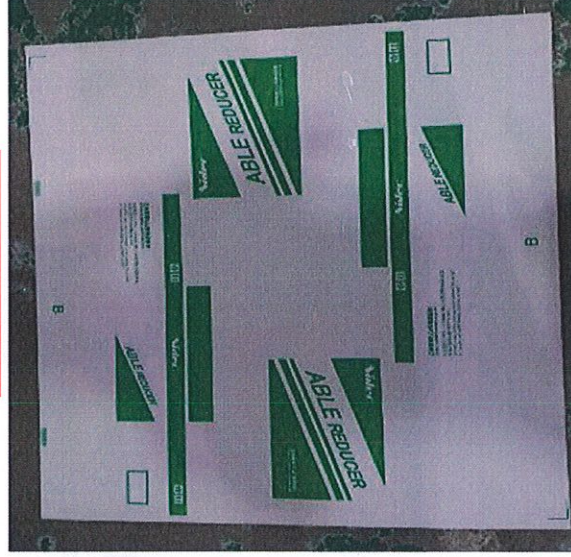
BEFORE

No sutureban on both ends

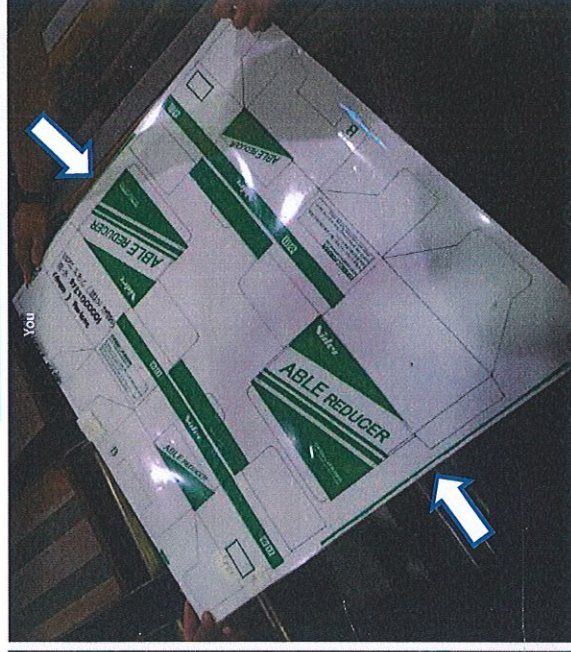
AFTER

With sutureban on both ends
