KANEPACKAGE PHILIPPINE INC.

INVESTIGATION REPORT FORM (IRF)
☒ Inhouse Detection

INVESTIGATION REPORT FOR POOR PRINT OF SANYO DENKI 00902010-01 PRINT SPECIFICATION

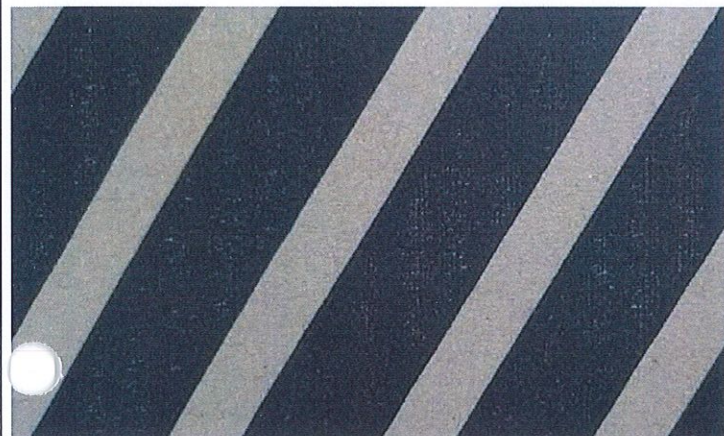
ILLUSTRATION OF THE PROBLEM

<input type="checkbox"/> Major <input type="checkbox"/> Minor	
Lot Quantity (pcs.)	Reject Quantity (pcs.)
3,260	81
Reject Percentage	
2.48%	
Nature of Defect:	
POOR PRINT	
Requirement:	
Solid print should no mottling print	
Actual:	
W/ mottling print on solid image

DIRECT CAUSE PROCESS/MATERIAL	"Based on investigation there is two possible caused of poor print"
	W1- Texture of the surface of materials is almost wash board.
	W2- Wash board effect to the print impression that possible caused poor print.
	W1- Uneven water distribution of the shower nozzle of Eqos machine.
	W2- The supply of water from left shower nozzle is minimal than the right shower nozzle.
	W3- The uneven distribution of water in ink may affect to the ink viscosity that may possible cause of Blotted & Poor Print.

- > Alert the Eqos operator regarding this issue.
 - Discuss the possible root cause of the problem.
 - Try to adjust the settings once they encountered wash board like adjustment in print impression.
 - Once they trap wash board materials upon issuance that possible cause of poor print, immediate inform the Leader in-charge for the coordination of affected items.
- > Request to Engineering to check the condition of anilox and the calibration of shower nozzle of Eqos Machine.

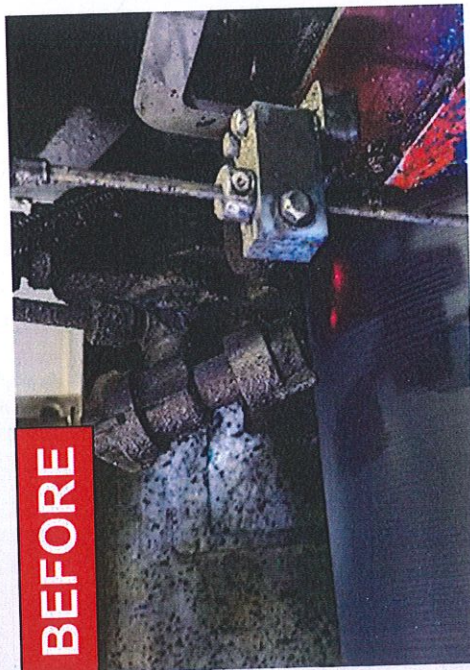
BEFORE

LEFT NOZZLE

>The nozzles were replaced because they produced water with uneven volumes

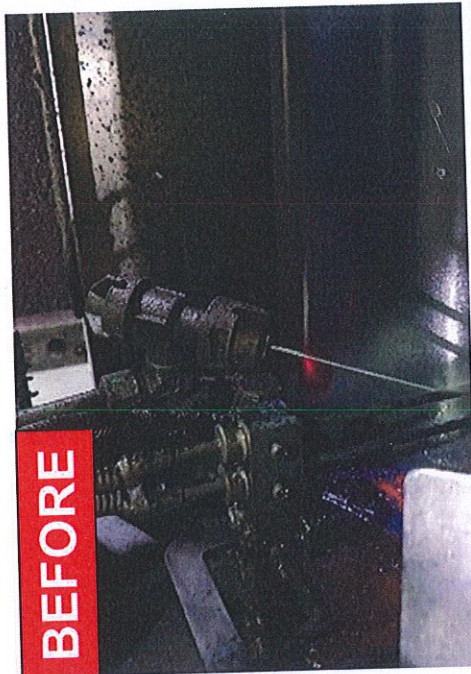
BEFORE

RIGHT NOZZLE
