**KANEPACKAGE PHILIPPINE INC.**

INVESTIGATION REPORT FORM (IRF)☒ Inhouse Detection☐ Customer Claim

Control No.: 404

INVESTIGATION REPORT FOR POOR PRINT OF SANYO DENKI 00902009-01 PACKAGE

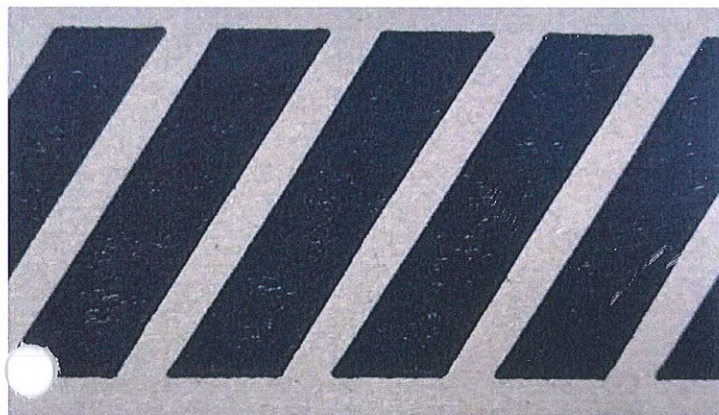
ILLUSTRATION OF THE PROBLEM

<input type="checkbox"/>	Major	<input checked="" type="checkbox"/>	Minor
Lot Quantity (pcs.)		Reject Quantity (pcs.)	Reject Percentage
3,300		451	13.66 %
Nature of Defect:			
POOR PRINT			
Requirement:			
No poor print on the solid image of the carton box			
Actual:			
W/ mottling on the solid image

ROUGH TEXTURE / UNEVEN DISTRIBUTION
OF MATERIALS OF WATER IN INK.

<i>Material</i> DIRECT CAUSE PROCESS/MATERIAL	"Based on investigation there is two possible caused of poor print"
	W1- Texture of the surface of materials is rough.
	W2- Rough texture of materials effect to the print impression that possible caused of poor print.
<i>Machine</i> PROCESS/MATERIAL	W1- Uneven water distribution of the shower nozzle of Eqos machine.
	W2- The supply of water from left shower nozzle is minimal than the right shower nozzle.
	W3- The uneven distribution of water in ink may affect to the ink viscosity that may possible cause of Poor Print & Blotted.

> Since Production did not control the rough texture of materials, our action plan is to try the Soft cyrel for the solid image print and Hard cyrel for the small character print. (PR done)			
> Engineering schedule to conduct assessment today for the Shower Nozzle.			
PIC:	PRODUCTION	TARGET DATE:	ON-GOING

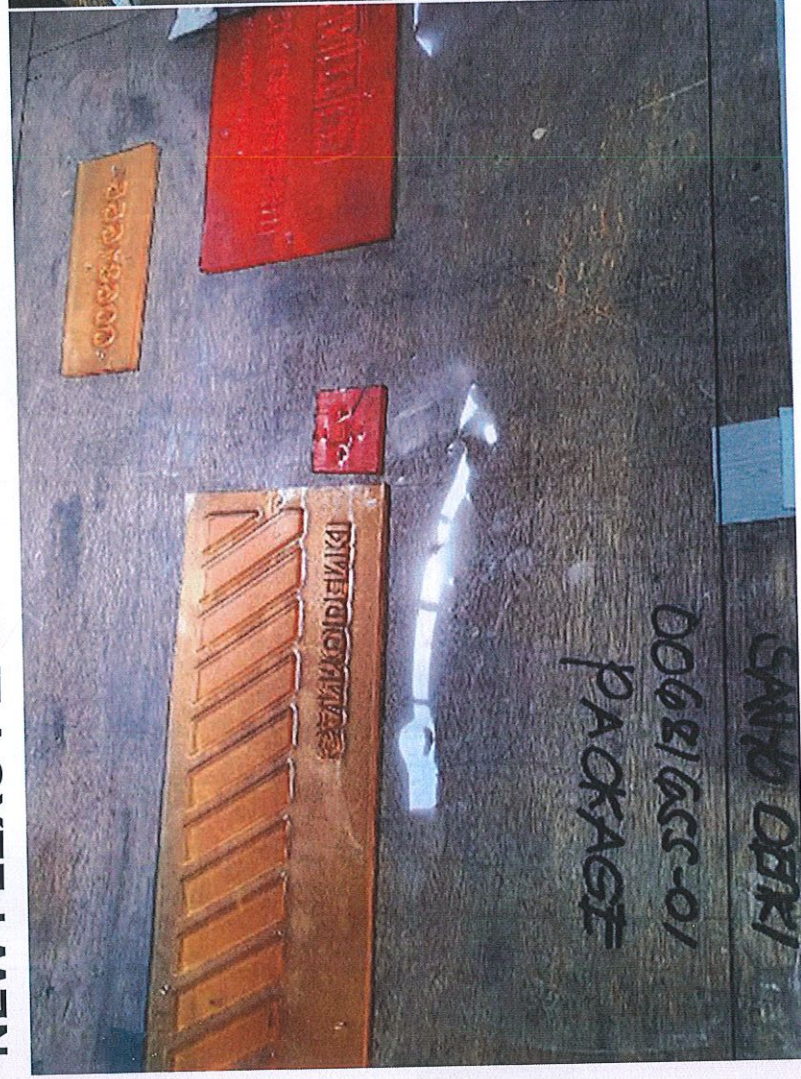
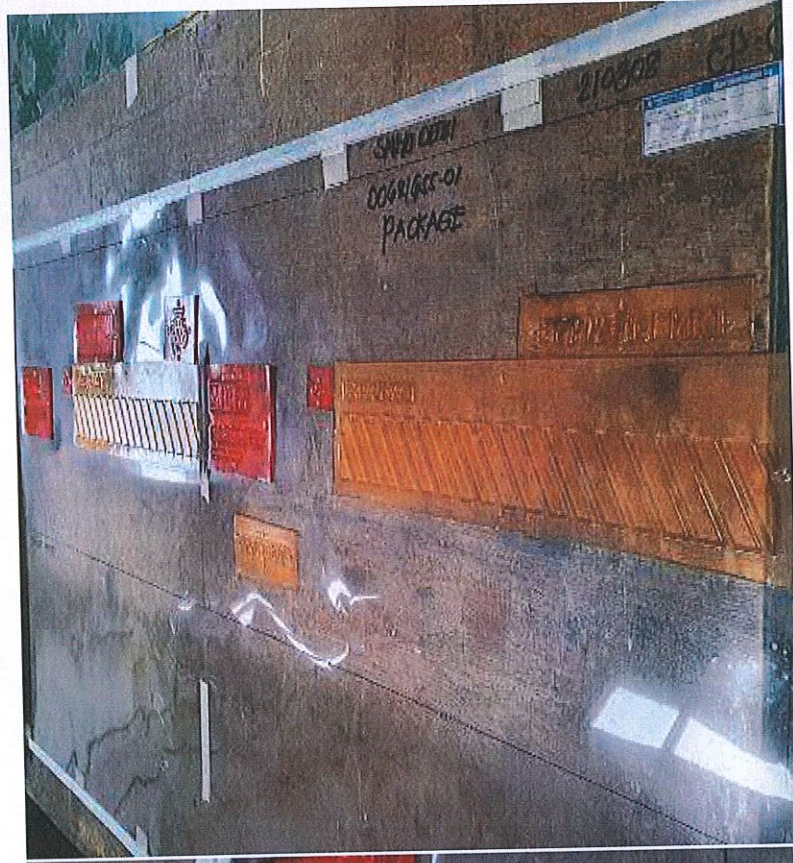
NEW FLEXO PLATE SETUP:

NOTE: Light color rubber dies are soft flexoplate and the dark color rubber dies are hard flexoplate.

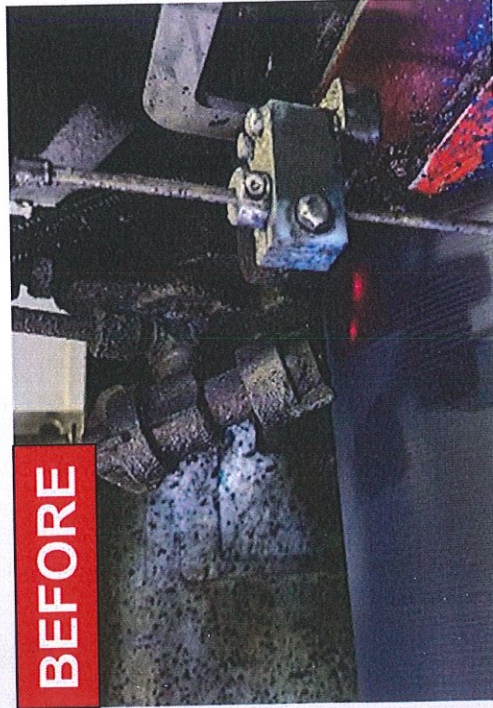
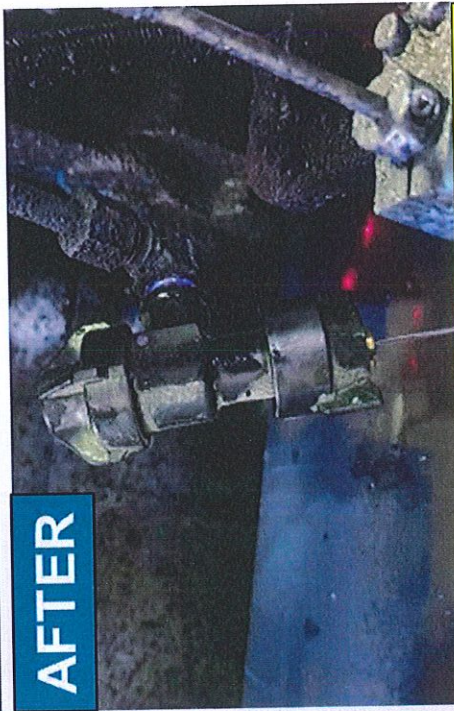
LEFT NOZZLE

>The nozzles were replaced because they produced water with uneven volumes

Checked by	Date	Implemented?	Remarks
1st Verification of Action	A. Vergara	21 03 24	<input checked="" type="checkbox"/> Yes <input type="checkbox"/> No	Water shower in printing unit 2 was replaced
2nd Verification of Action	A. Vergara	21 04 06	<input checked="" type="checkbox"/> Yes <input type="checkbox"/> No	The flexoplate was replaced
3rd Verification of Action			<input type="checkbox"/> Yes <input type="checkbox"/> No	
Effectiveness of Action	A. Vergara	21 07 07	<input checked="" type="checkbox"/> Yes <input type="checkbox"/> No	C.A. is effective
